WASHINGTON BLVD CORRIDOR STUDY

Introduction

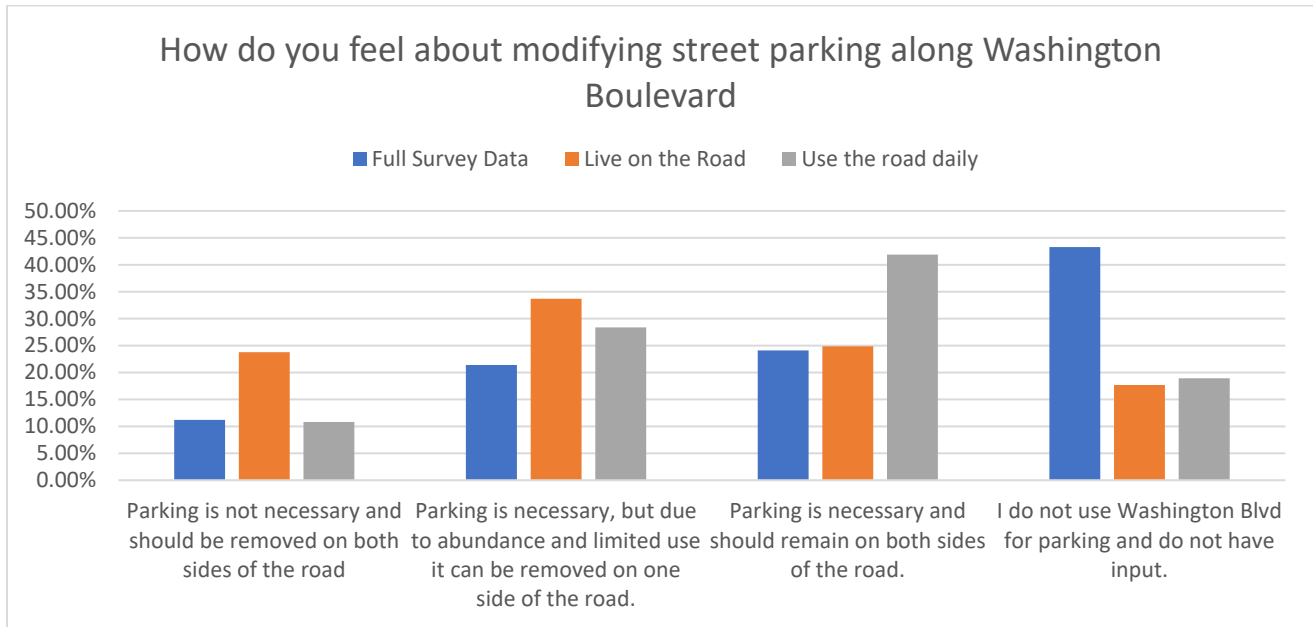
Figure 5. How do you feel about modifying street parking along Washington Boulevard to allow for traffic calming/bike accommodations to be implemented? (Percent Breakdown)

In analyzing data from the second Washington Blvd question, TEG noted that for the overall response data most respondents did not use parking on Washington Blvd and had no input (43%). Of the group who did have input on parking most of those people believe parking is required (45% combined responses that parking is necessary on one or both sides). Of the two groups who say parking is necessary, over half of them feel parking is required on both sides of the road.

to removing parking on one or both sides. Knowing this, TEG will try to maintain parking on one side in the recommended alternatives along Washington Blvd. It is likely some parking will be removed to avoid providing an overabundance of parking like in the existing conditions, and to make room for more effective traffic calming improvements.

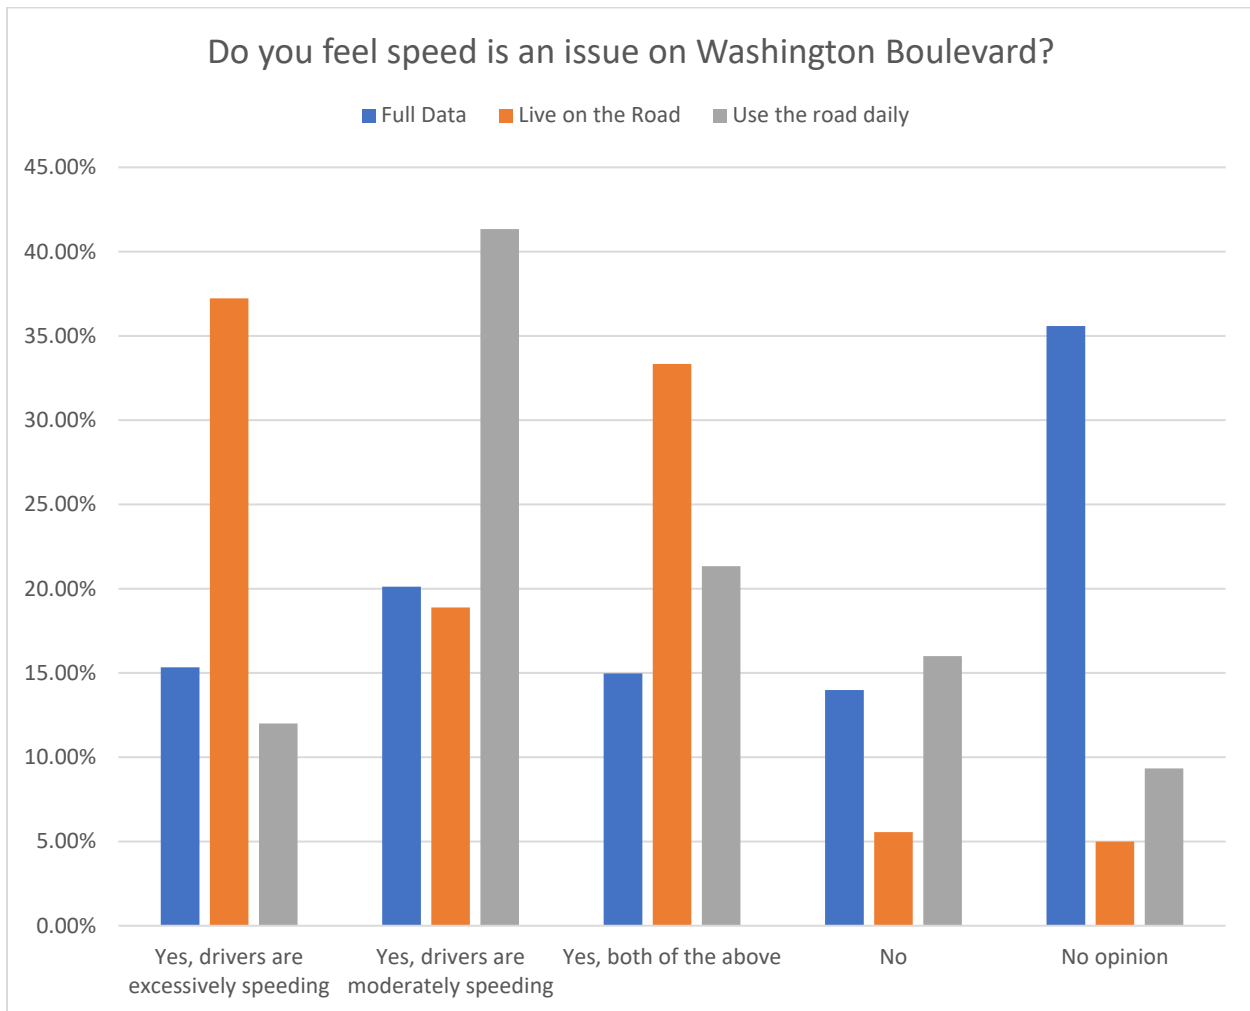
Figure 6. Do you feel speed is an issue on Washington Boulevard? (Percent Breakdown)

When answering this question 50% of respondents (or 75% of those who offered an opinion) felt speed was an issue (moderate and/or excessive) on Washington Blvd. The overwhelming majority of road users feel speeding is an issue or have no opinion on it.

Those residents with more experience with the road feel more strongly that speeding is a significant issue along Washington Blvd. In figure 6 it is apparent that residents using the road daily are more likely to believe drivers are either moderately or excessively speeding compared to the full data set. The residents who live on the road followed a similar trend with the exception that these respondents thought drivers were excessively speeding as opposed to moderately speeding. Residents who live along Washington Blvd

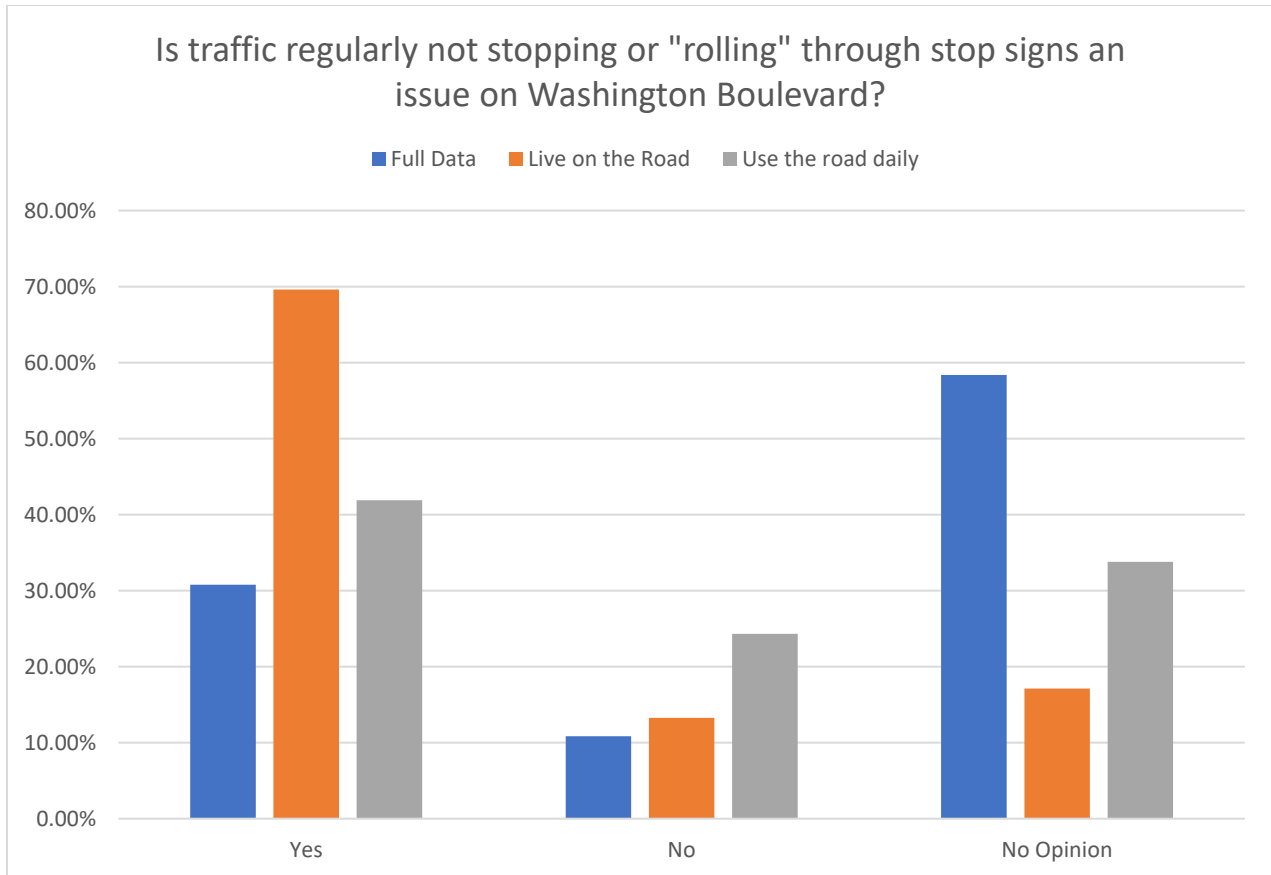
Figure 7. Is traffic regularly not stopping or "rolling" through stop signs an issue on Washington Boulevard? (Percent Breakdown)

When asked about stopping along Washington, 30% of all respondents felt drivers were either not stopping or rolling through stop signs. This is alarming because this perceived behavior might discourage pedestrians and cyclists from using the road or the nearby parks for safety reasons. 11% of respondents did not feel lack of stopping was an issue, with over 50% of respondents having no opinion. This is expected because drivers who don't often use the road have less of a chance to observe this driver behavior compared to drivers regularly using Washington Blvd.

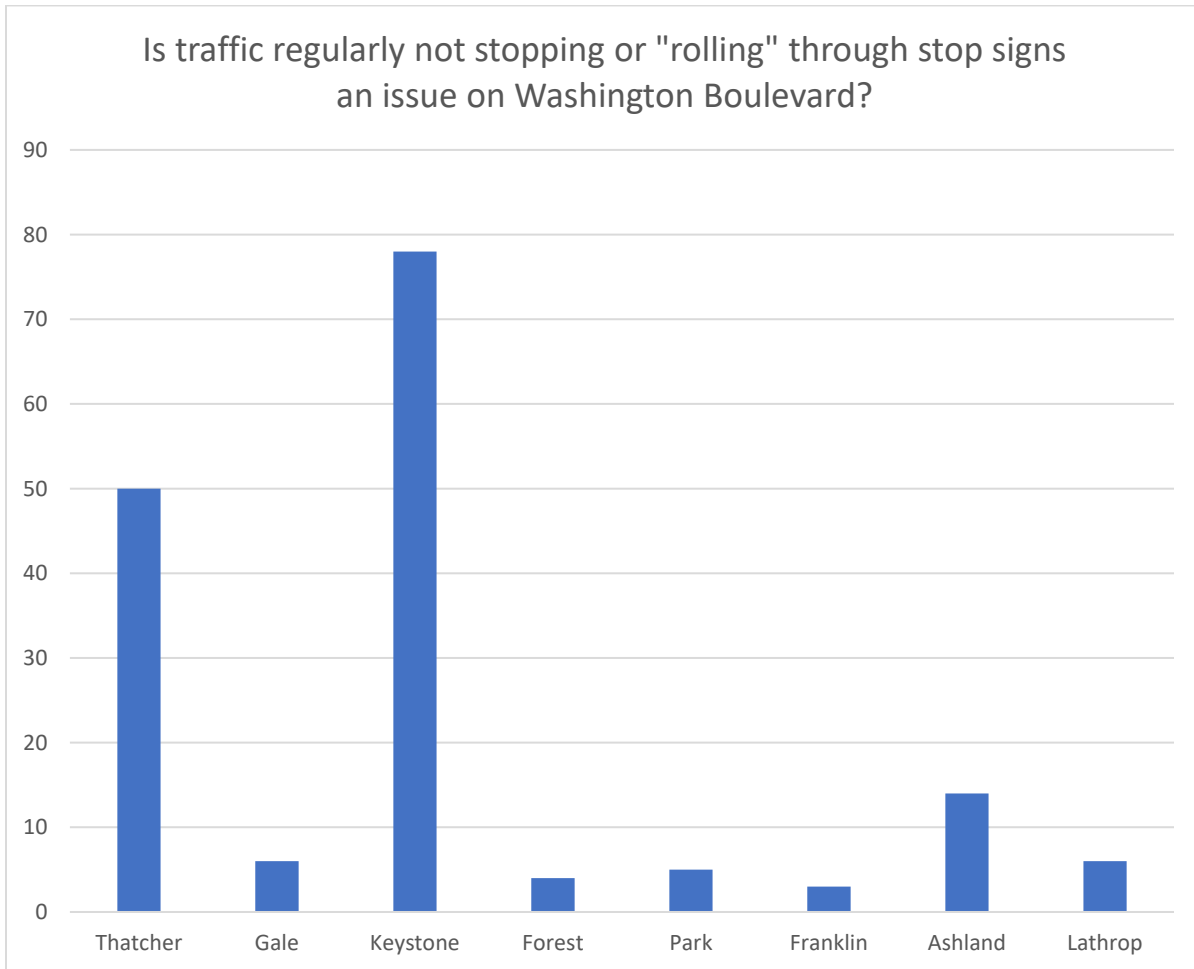
Figure 8. Open ended response data in response to the prior question.

The survey results clearly show that residents believe there are issues at both Thatcher Ave and Keystone Ave. Crash data supports this and indicates that more severe traffic calming may need to be considered at these two intersections.

The moderate spike in residents saying drivers were rolling the stop signs on Ashland Ave (14) may be an effect of the setback geometry of the minor legs. Drivers approaching Washington Blvd from Ashland may go past the stop bar while stopping to get a better view of oncoming traffic. Currently drivers are stopped over 40' away from Washington Blvd which is more than double the setback of intersections in the western half of the corridor. Geometric modifications would improve functionality and driver behavior without requiring further traffic calming.

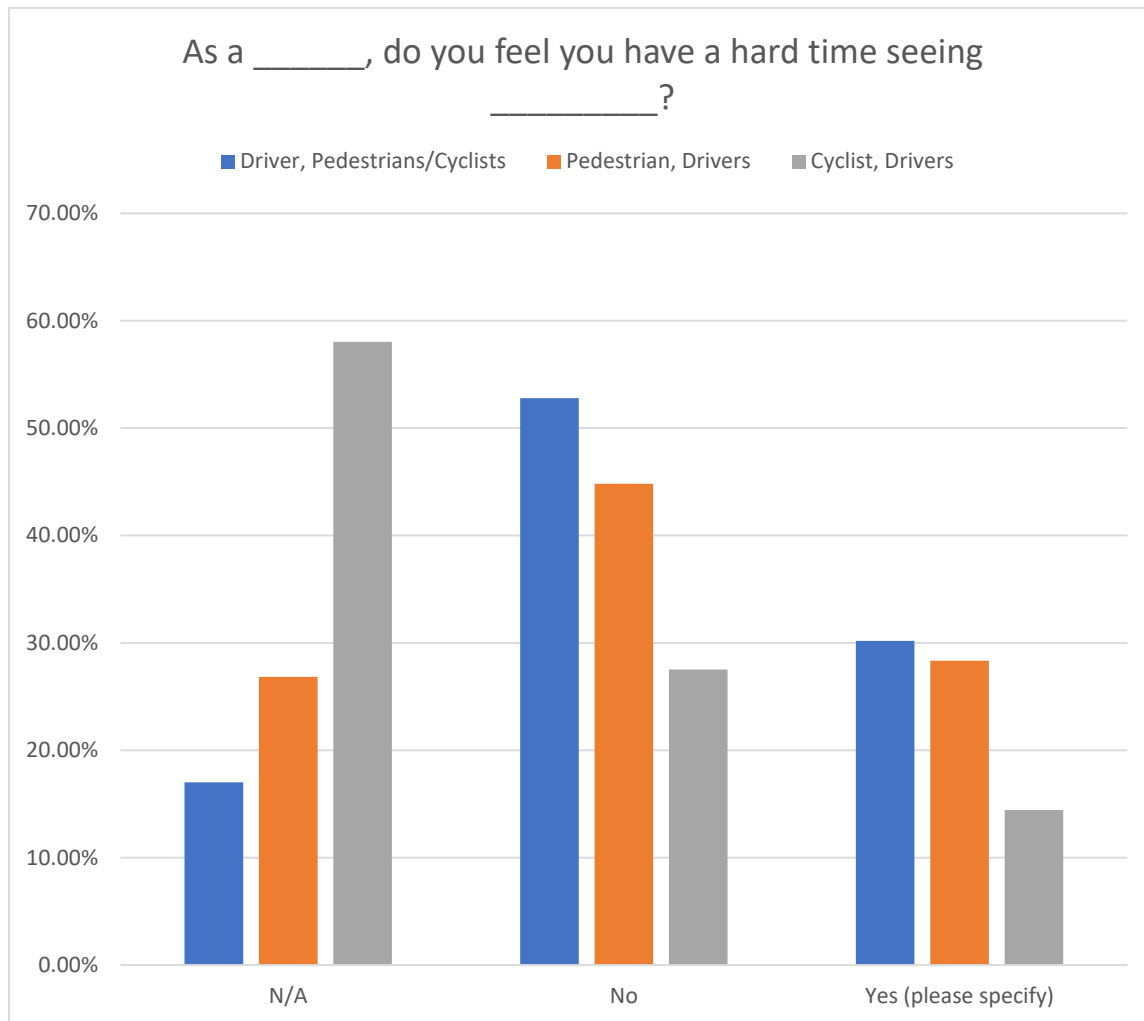
Figure 9. Drivers, Pedestrians, and Cyclists response regarding being seen along Washington Blvd.

The final three questions seek to understand the average experience using Washington Blvd from the perspective of a driver seeing pedestrians and cyclists, a pedestrian seeing oncoming vehicles, and a cyclist seeing oncoming vehicles. All three questions had an open response section to try and narrow down the specific intersections drivers and pedestrians feel most at risk.

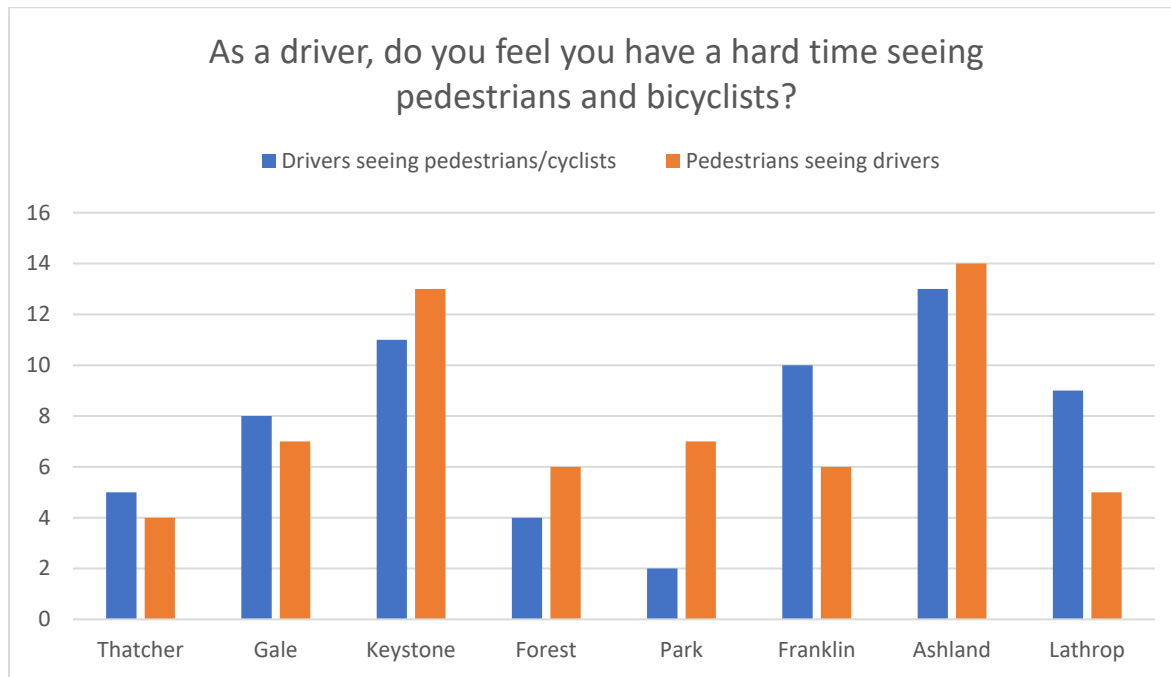
Figure 10. Open ended responses by Drivers and Pedestrians from the previous question.

Based on the side-by-side charts it is clear there is an overlap between pedestrian and driver perception of the areas where sightlines may be compromised. For both open-ended response sections 62 residents left feedback. While the overall distributions may be different the clear pattern is that Keystone and Ashland are perceived as intersections where sight distances are compromised.

The responses claiming Keystone has compromised sightlines were surprising for TEG. Knowing that drivers often roll through the stop at the intersection may explain some of the responses, but TEG did not feel the trees and landscaping around the intersection would impact drivers' ability to spot pedestrians approaching to that extent. This is especially true if a driver came to a complete stop and assessed their surroundings before continuing forward.

The remaining responses were spread across the corridor. The next most mentioned intersection was at Gale Ave with 15 respondents mentioning concerns on Gale between pedestrian and driver responses. This makes sense based on the density of trees and landscaping around the intersection. The fact that drivers on Washington Blvd do not need to stop makes it harder for them to register a pedestrian crossing or waiting to cross amongst the other visual clutter. Currently there is sidewalk crossing Washington Blvd on the east and west legs with no crosswalk to indicate to drivers that pedestrians may be crossing in the area.

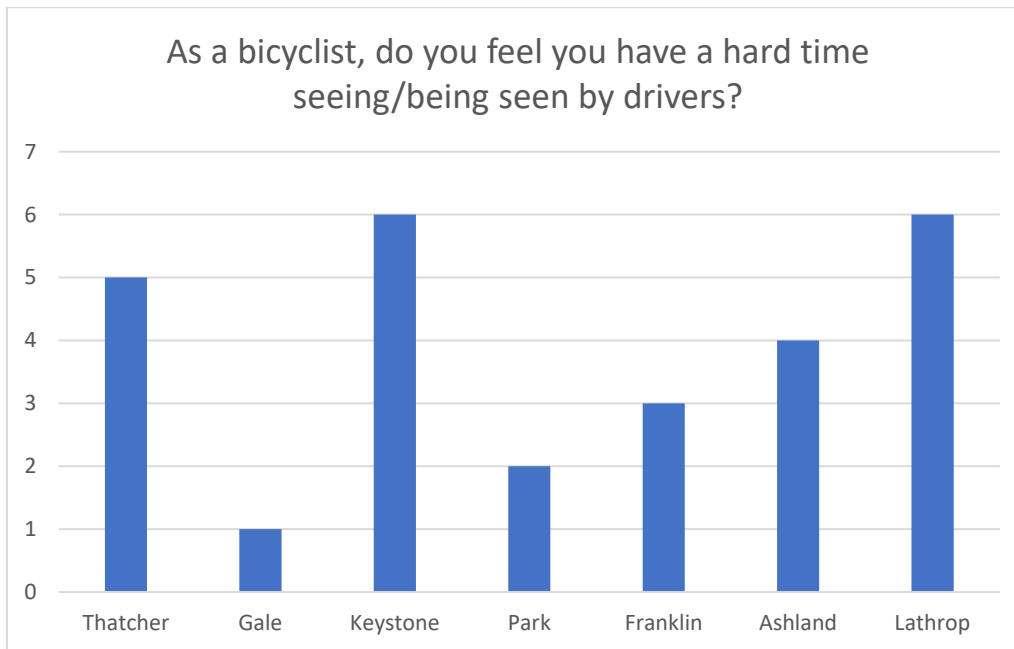
Figure 11. Open ended responses by Cyclists to the previous question.

Cyclists had a much smaller pool of open-ended responses (27) due to less residents regularly cycling on Washington Blvd. Their responses may be from the perspective of a rider entering Washington Blvd from a side street or a rider navigating Washington Blvd. Clearly, the two all-way stop intersections of Thatcher Ave and Keystone Ave are concerning to cyclists. This may correspond with the perception that drivers regularly do not stop at those two intersections. More cyclists felt they couldn't be seen as we head east through the intersections of Park Ave, Franklin Ave, Ashland Ave, and Lathrop Ave. TEG speculates that this is due to the unique geometry in that portion of the corridor and cyclists feeling less safe/seen at signalized intersections generally. Providing protected bike facilities would be the best way to give bicyclists a designated place on the road where drivers can expect cyclists.

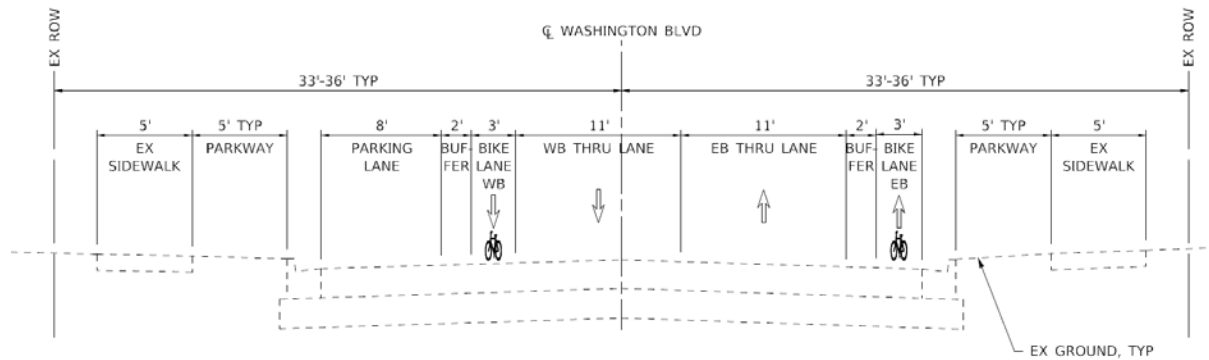
THATCHER AVE - PARK AVE
(FACING EAST)

WESTERN ALTERNATIVE 1

Figure 12. Proposed Western Typical Section Washington Blvd.

All recommendations discussed above have been compiled and drafted into a proposed exhibit for Washington Blvd and can be seen in Appendix F.05: Washinton Blvd Exhibits. Within the exhibits TEG used the preferred design and cross section as detailed above. TEG is proposing an alternative roadway cross section throughout the corridor. We have developed two new typical sections, one for the east half and one for the west half with the transition point at Park Ave. The western cross section maintains all parking along the north side of Washington Blvd, narrows the lanes to 11' in each direction, and provides a 3' bike lane with 2' buffer on the north and south side of the street (See figure 12 below). The eastern cross section will keep the current lane configuration from Park Ave to Lathrop Ave, but lanes will be reduced to 11' widths and a two-foot striped median will be installed (See figure 13 below). Throughout the eastern section, cyclists will be provided 8' multi-use paths north and south of Washington Blvd. TEG updated our capacity model to function without right-turn slip lanes at the intersections and found only minor changes in the overall capacity of the road (See Appendix C.03: Alternative Volumes & Level of Service – AM and Appendix C.04: Alternative Volumes & Level of Service – PM).

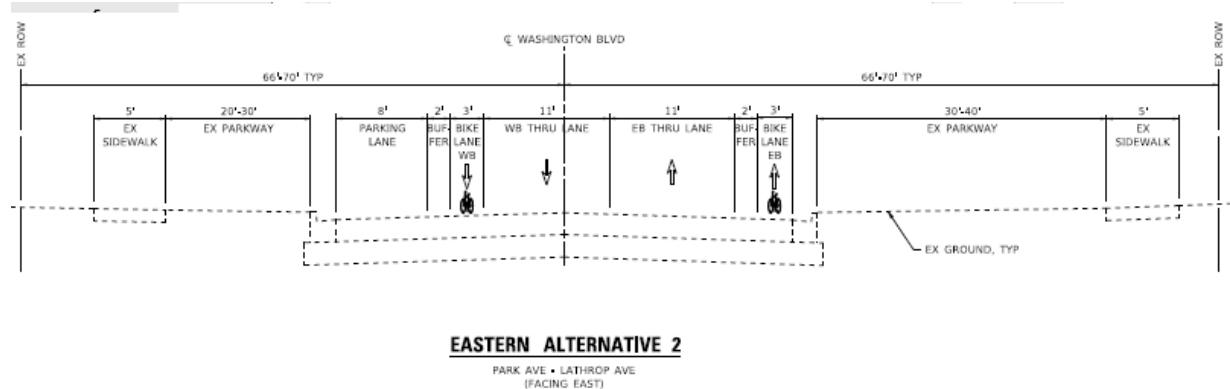
Eastern Alternative 2 is identical to West Alternative 1. Parking will remain in place along the north side of the road and will be removed from the south side of the road. The cross section provides 8' of parking along the north side of the road, a 2' buffer, a 3' westbound bike lane, two 11' through lanes, a 2' buffer, and 3' eastbound bike lane. Curb extensions will still be provided along the north side of the road and sidewalks will still be realigned at the intersections to be closer to Washington Blvd.

Figure 16. Eastern Typical Section Alternative 2 Washington Blvd.

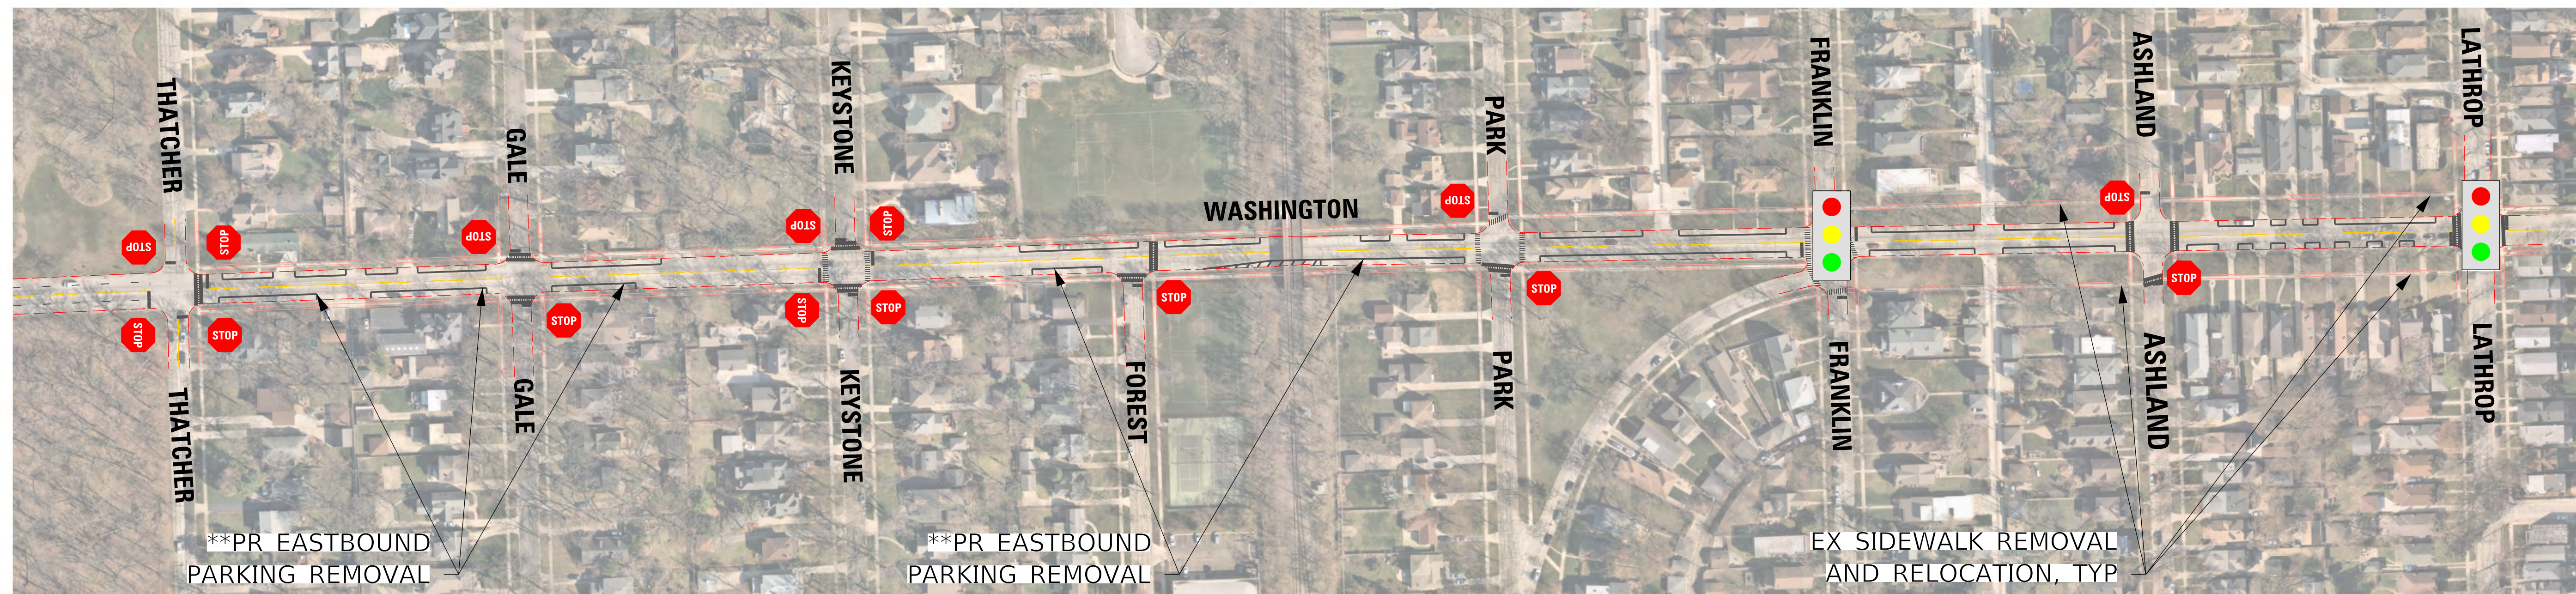
WASHINGTON BLVD EXISTING

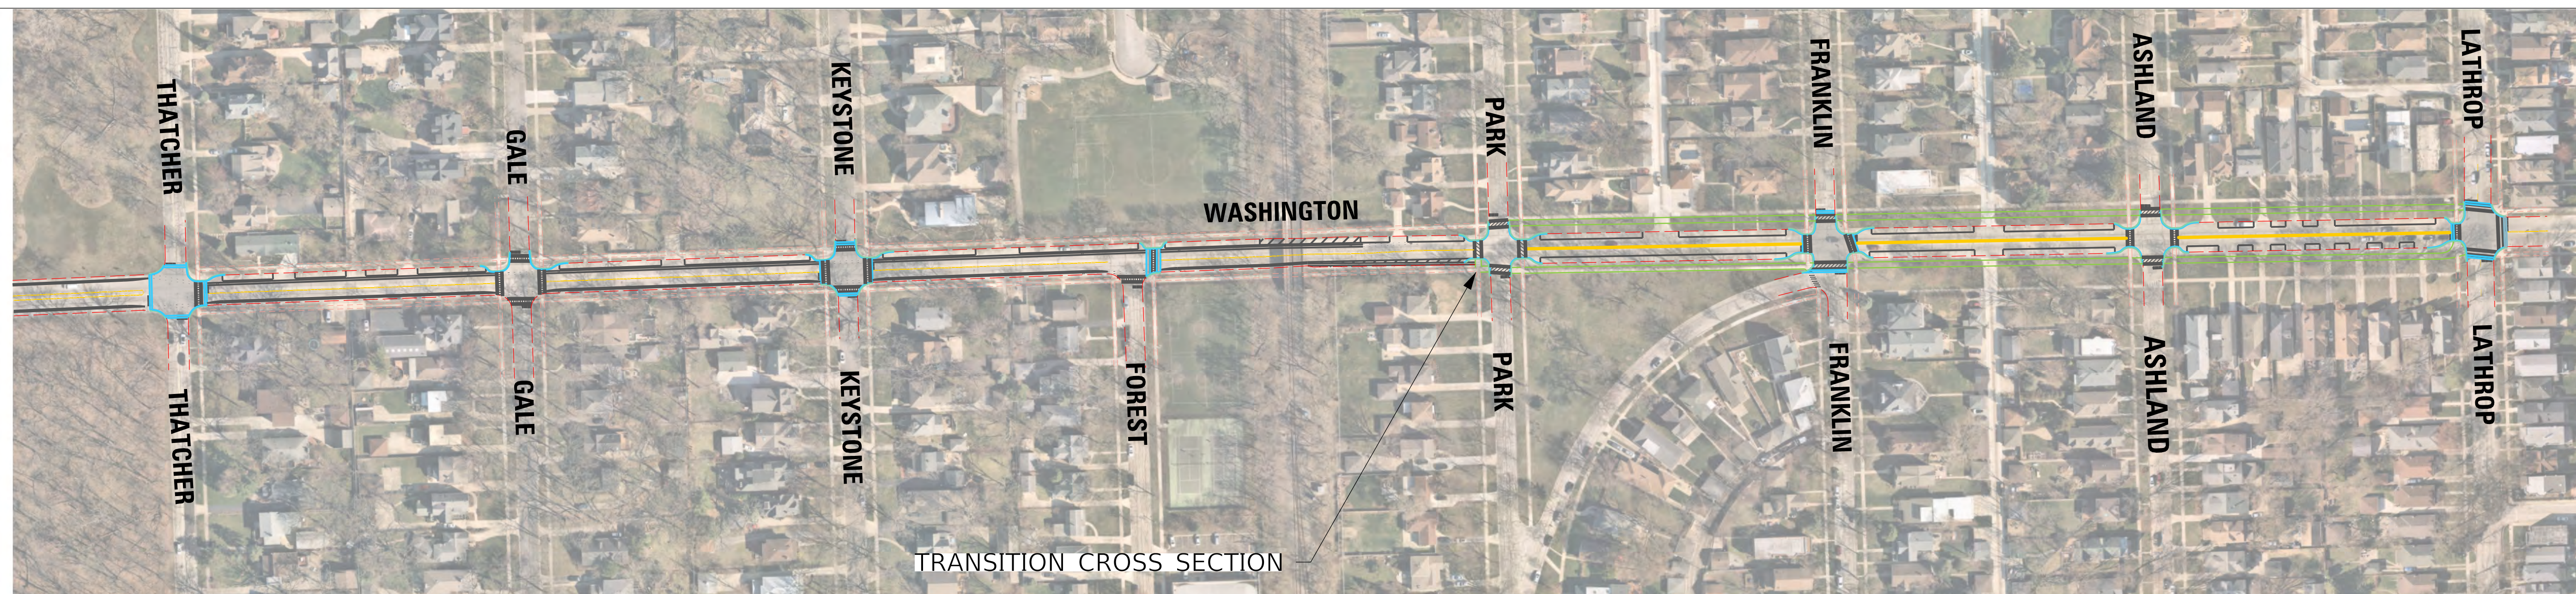
1. RAISED INTERSECTIONS: FRANKLIN AVE & LATHROP AVE
2. FROM PARK AVE TO LATHROP AVE THE CROSS SECTION WILL REMAIN THE SAME WITH THE ADDITION OF A 2' STRIPED CENTER MEDIAN ALONG WITH CURB EXTENSIONS AT ALL INTERSECTIONS.
3. STARTING AT PARK AVE TO THE EAST THE ON-STREET BIKE LANES WILL BE MOVED TO AN OFF-STREET MULTI-USE PATH. TEG CURRENTLY SHOWS THE PATH ON BOTH SIDES OF THE ROAD.
4. THE EXISTING SIDEWALK STARTING AT PARK AVE TO THE EAST WILL BE REMOVED IN FAVOR OF THE PR MULTI-USE PATH PLACED 5' FROM THE BACK CURB. STRIPING WILL BE REPLACED WITH NEW ZEBRA STRIPING.

WASHINGTON BLVD PROPOSED

** APPROXIMATELY 35 EASTBOUND PARKING SPOTS ARE BEING REMOVED FROM THE ROAD OR 45% OF ALL EASTBOUND PARKING. IT IS ASSUMED THE REMAINING PARKING SPACES, AS WELL AS, SIDE STREET PARKING WILL ACCOMODATE DRIVERS LOOKING TO PARK IN THE AREA

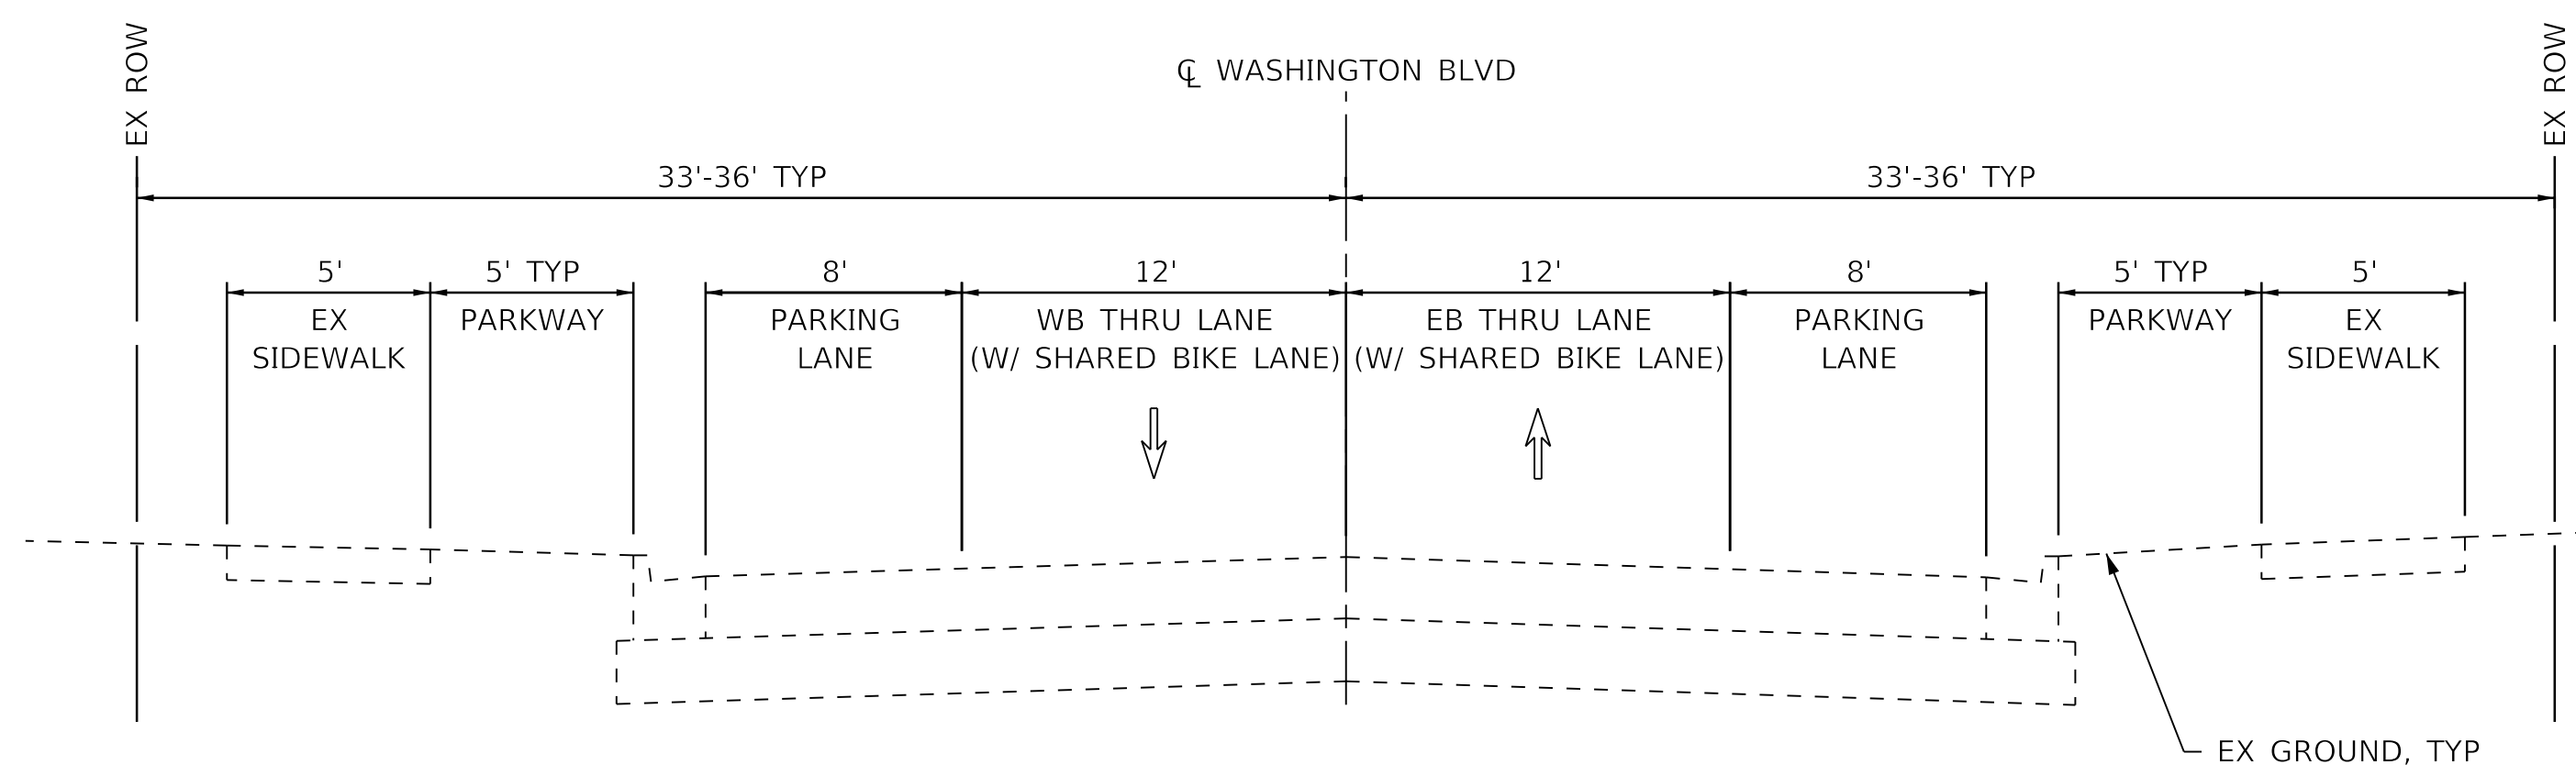
THATCHER AVE - PARK AVE
(FACING EAST)

EXISTING WESTERN TYPICAL SECTION

The typical cross section of Washington Blvd is two 12' lanes with 8' of parking on either side. The total width of the road is 40'. The road narrows to 36' at a railroad overpass located between Park and Forest Ave with 12'-7" of overhead clearance. The speed along all crossroads is 25 mph.

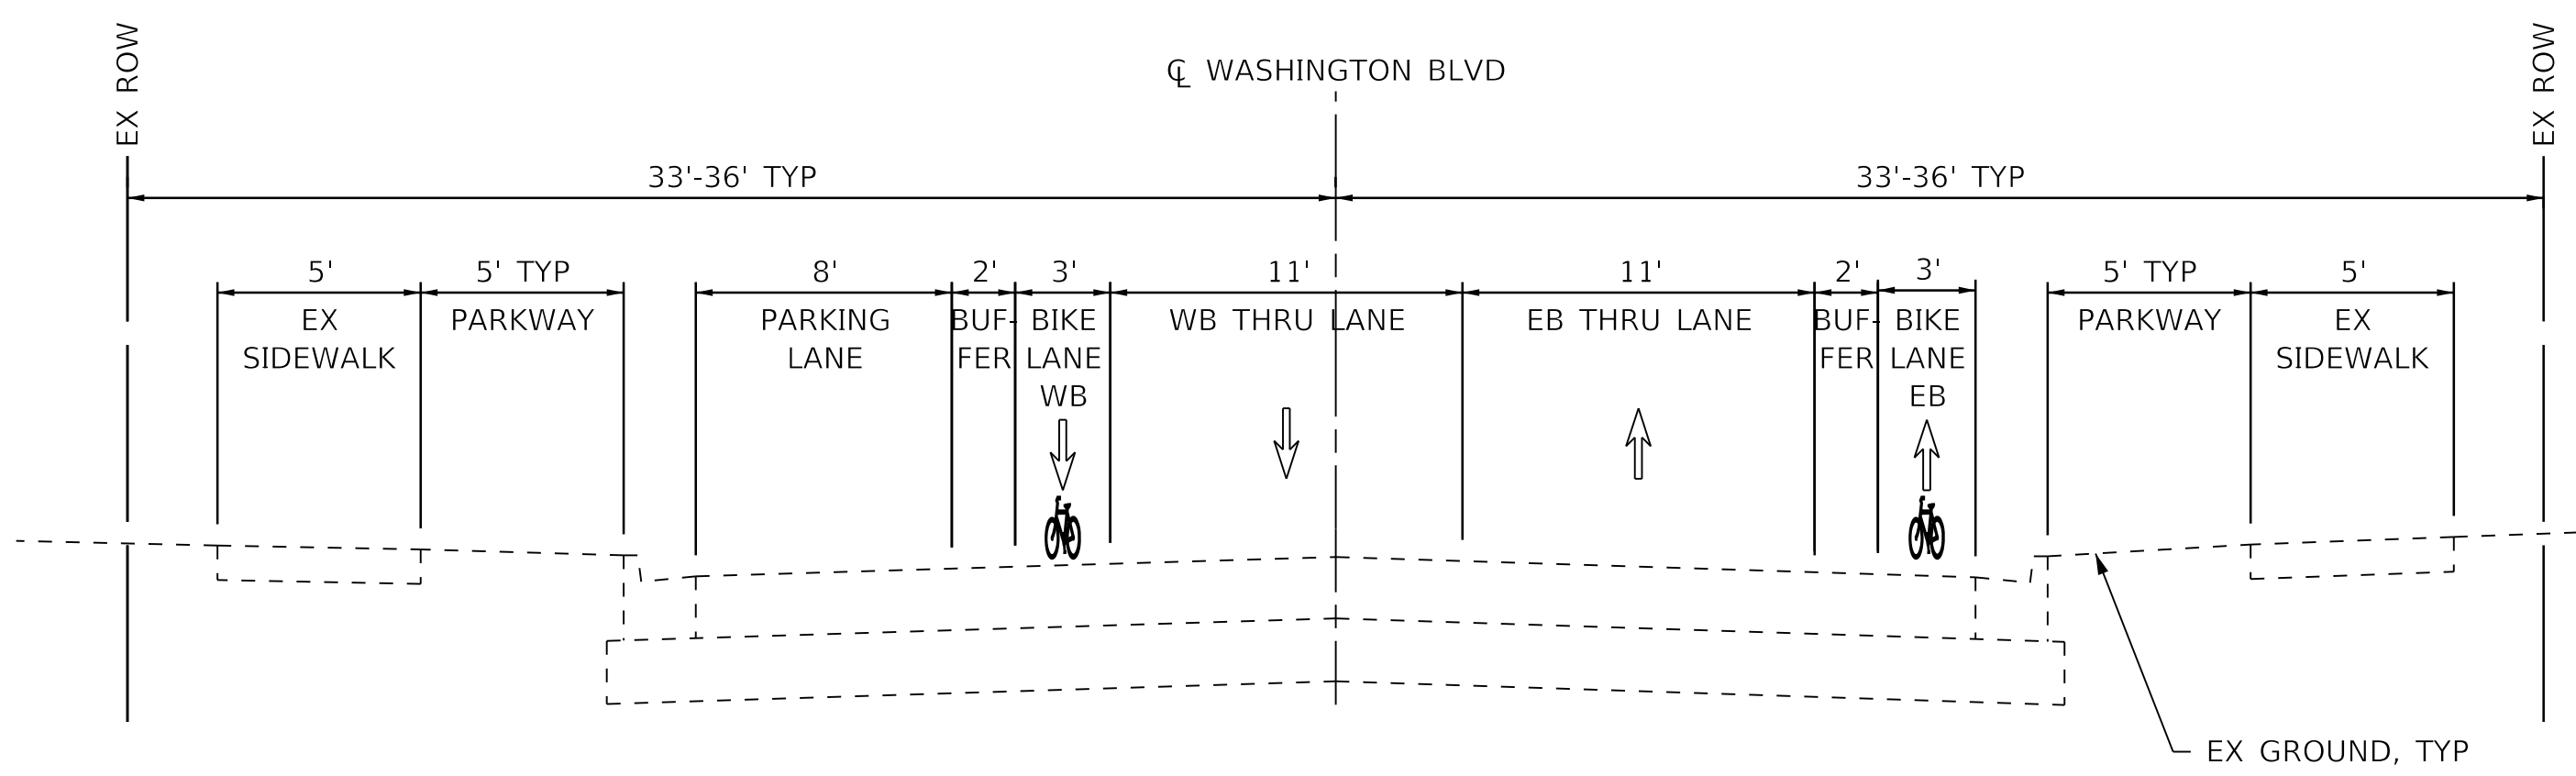
THATCHER AVE - PARK AVE
(FACING EAST)

WESTERN ALTERNATIVE 1

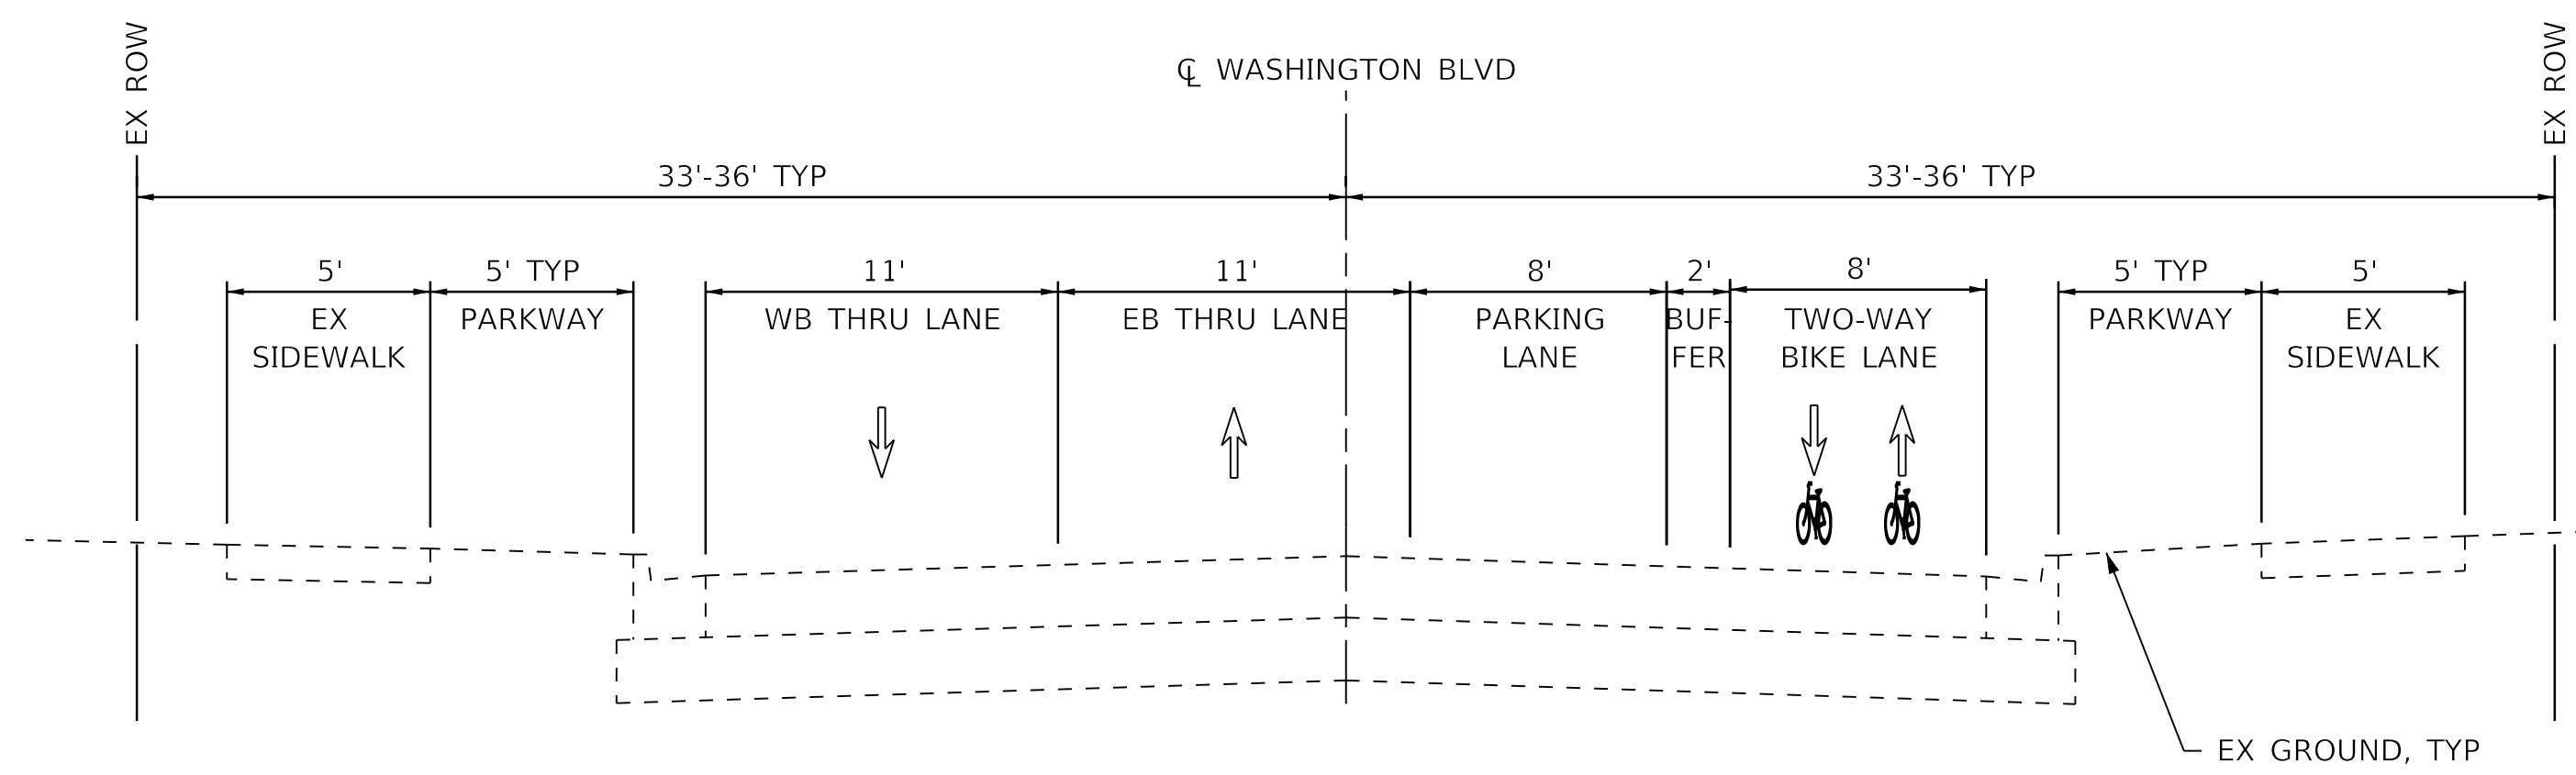
THATCHER AVE - PARK AVE
(FACING EAST)

WESTERN ALTERNATIVE 2

The Western Alternative 2 proposes two 11' through lanes along the north side of the road, an 8' parking lane, 2' buffer, and an 8' bi-directional bike lane. At Park Ave the cross section would transition to an off-street multi-use path and lanes would shift back to the south. Curb extensions may not be compatible with this cross-section design.

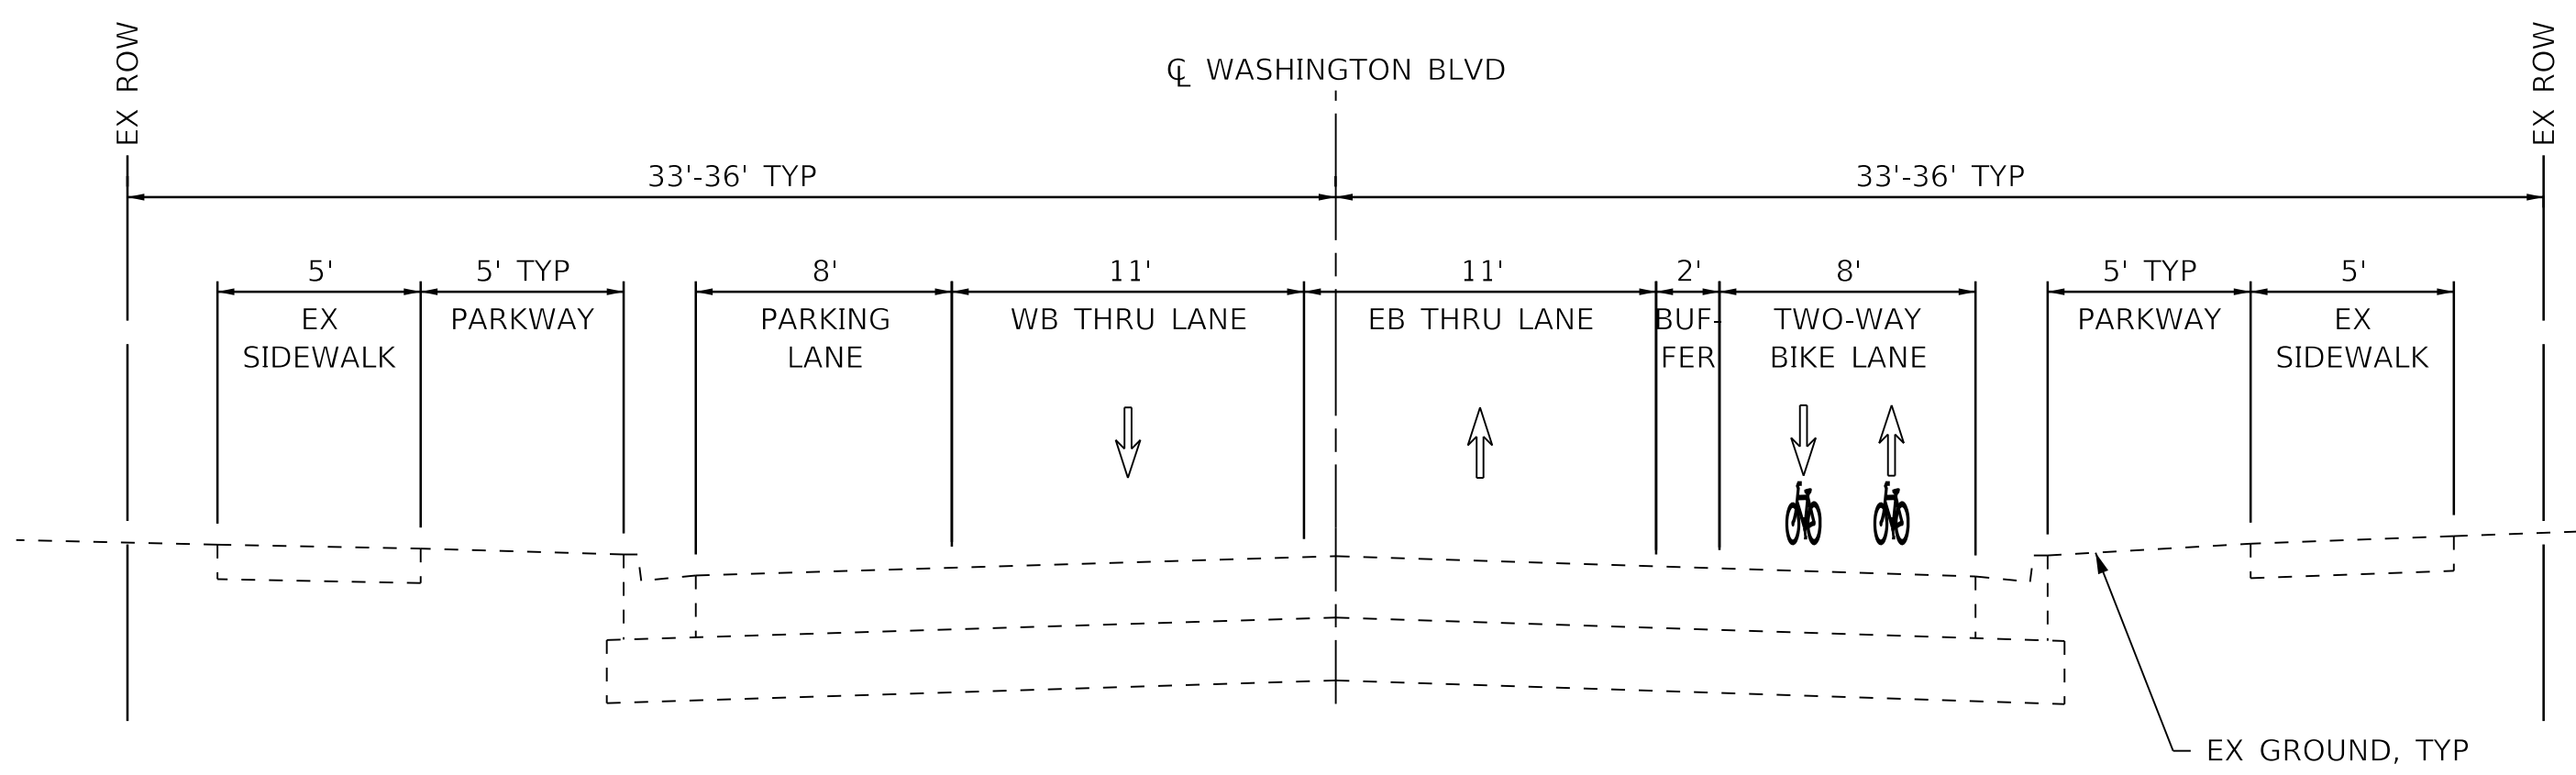
THATCHER AVE - PARK AVE
(FACING EAST)

WESTERN ALTERNATIVE 3

The Western Alternative 3 proposes an 8' parking lane along the north side of the road, two 11' through lanes, a 2' buffer, and an 8' bi-directional bike lane. At Park Ave the cross section would transition to an off-street multi-use path. Curb extensions can still be provided at the northern corners using this design.
