WASHINGTON BLVD CORRIDOR STUDY

Introduction

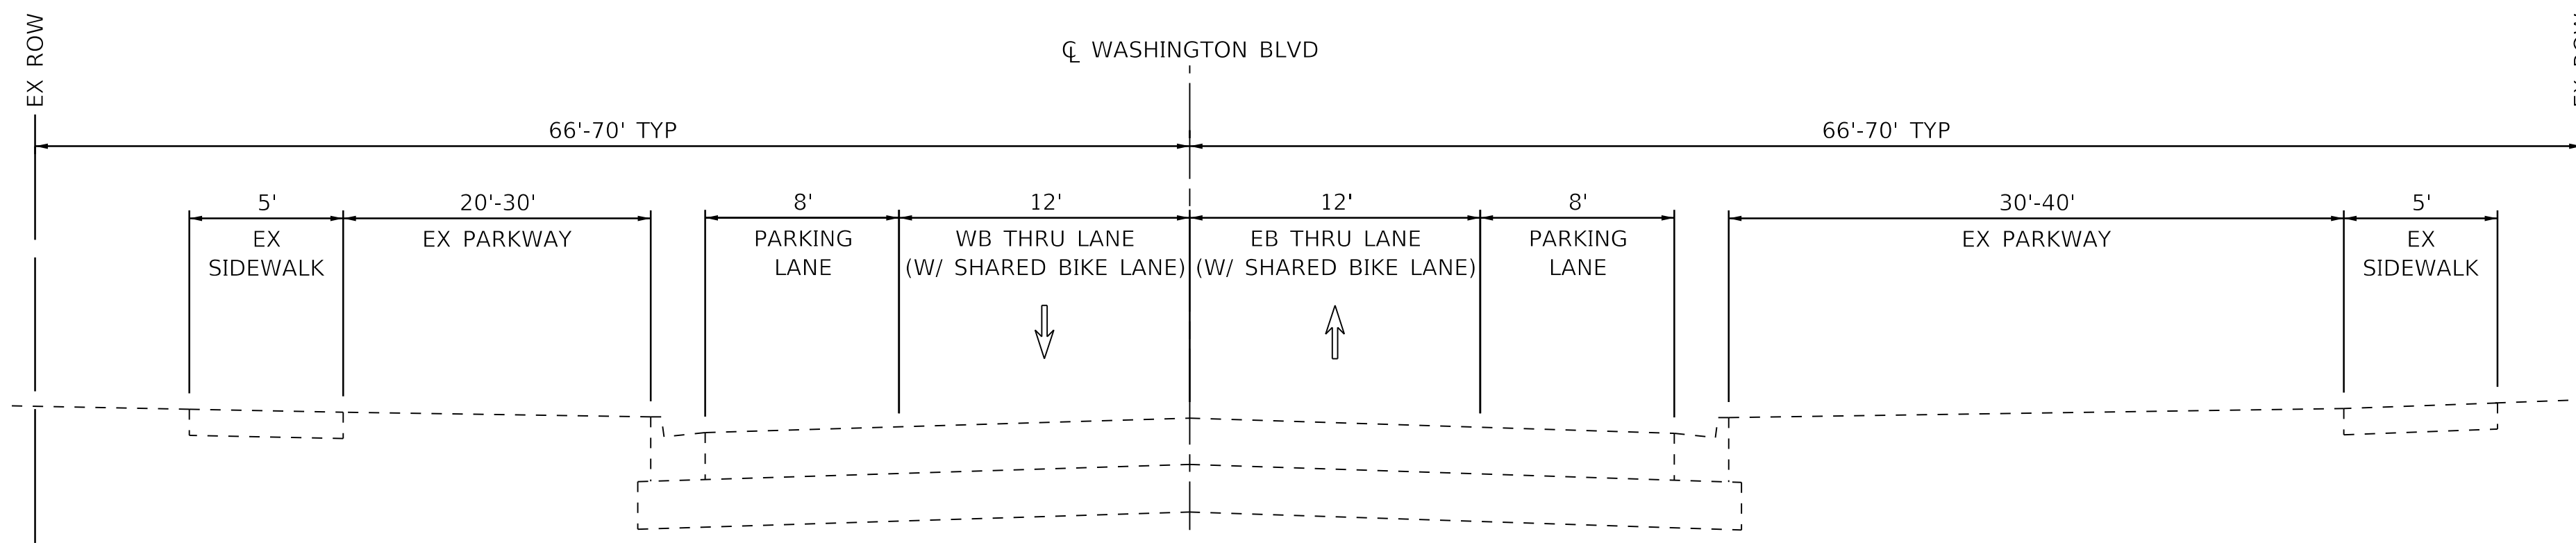
EXISTING EASTERN TYPICAL SECTION

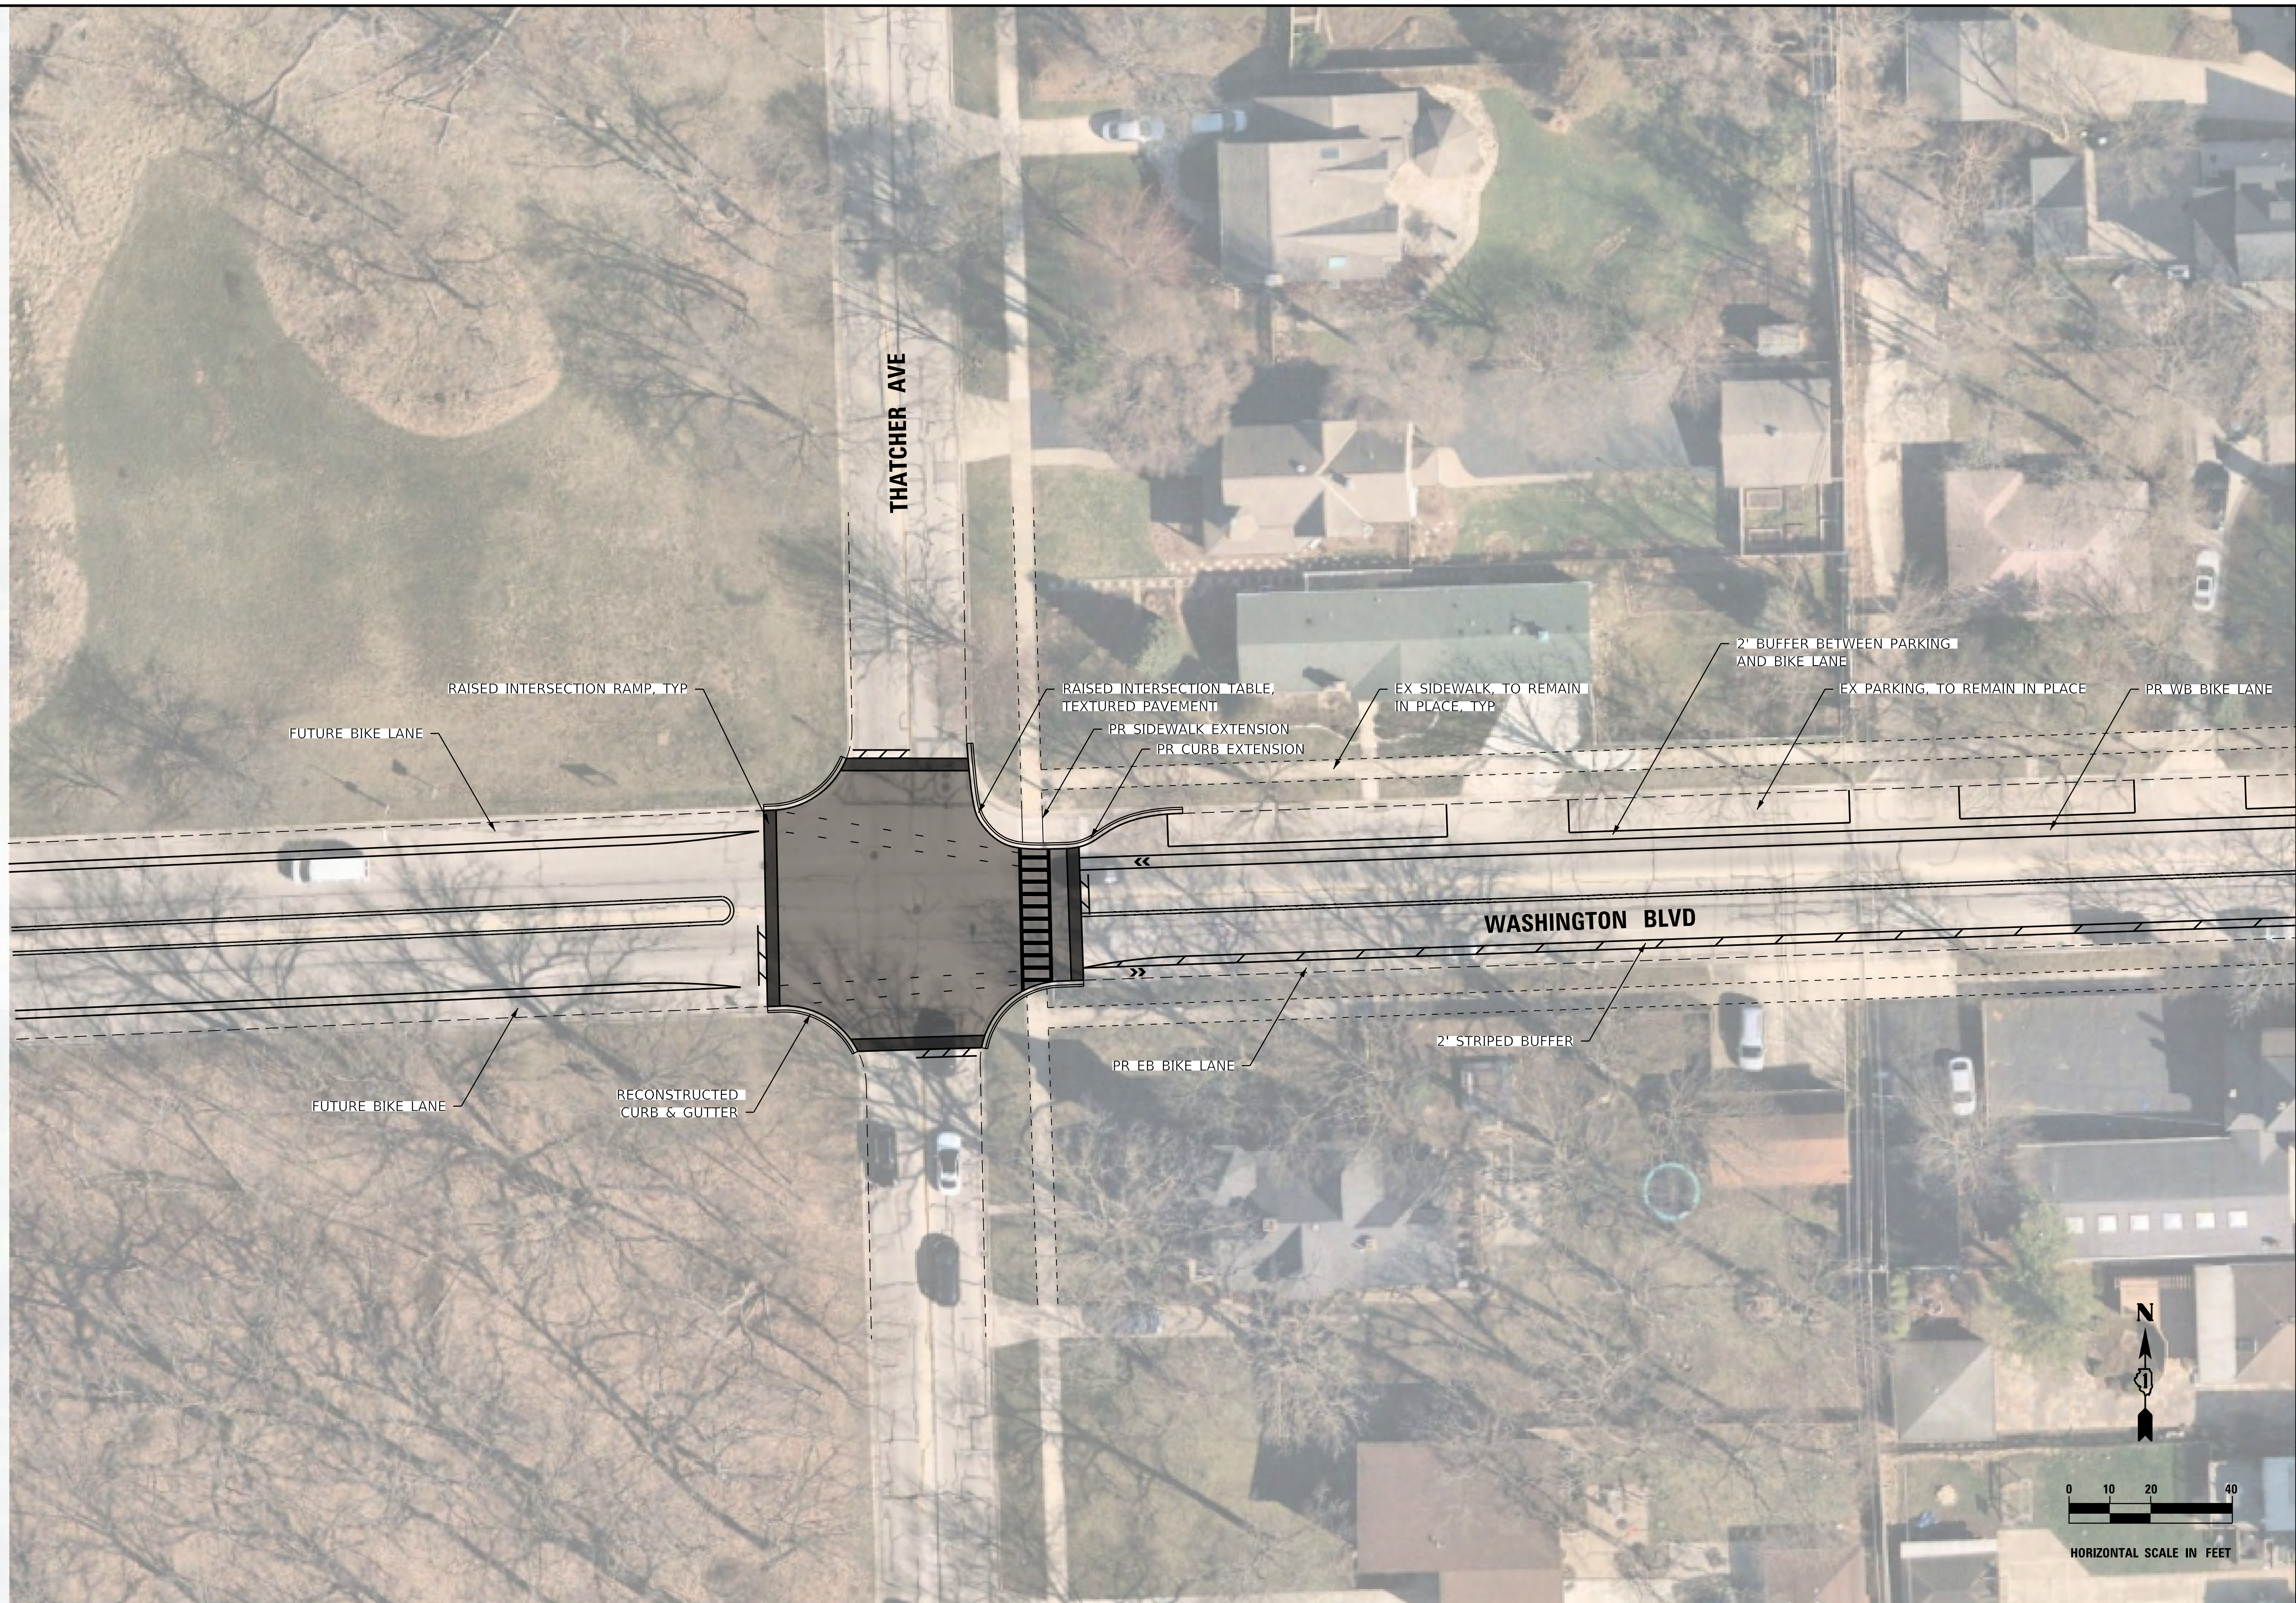
DRAWING NO.
4 OF 14

**WASHINGTON AT THATCHER
 ALTERNATIVE 1**

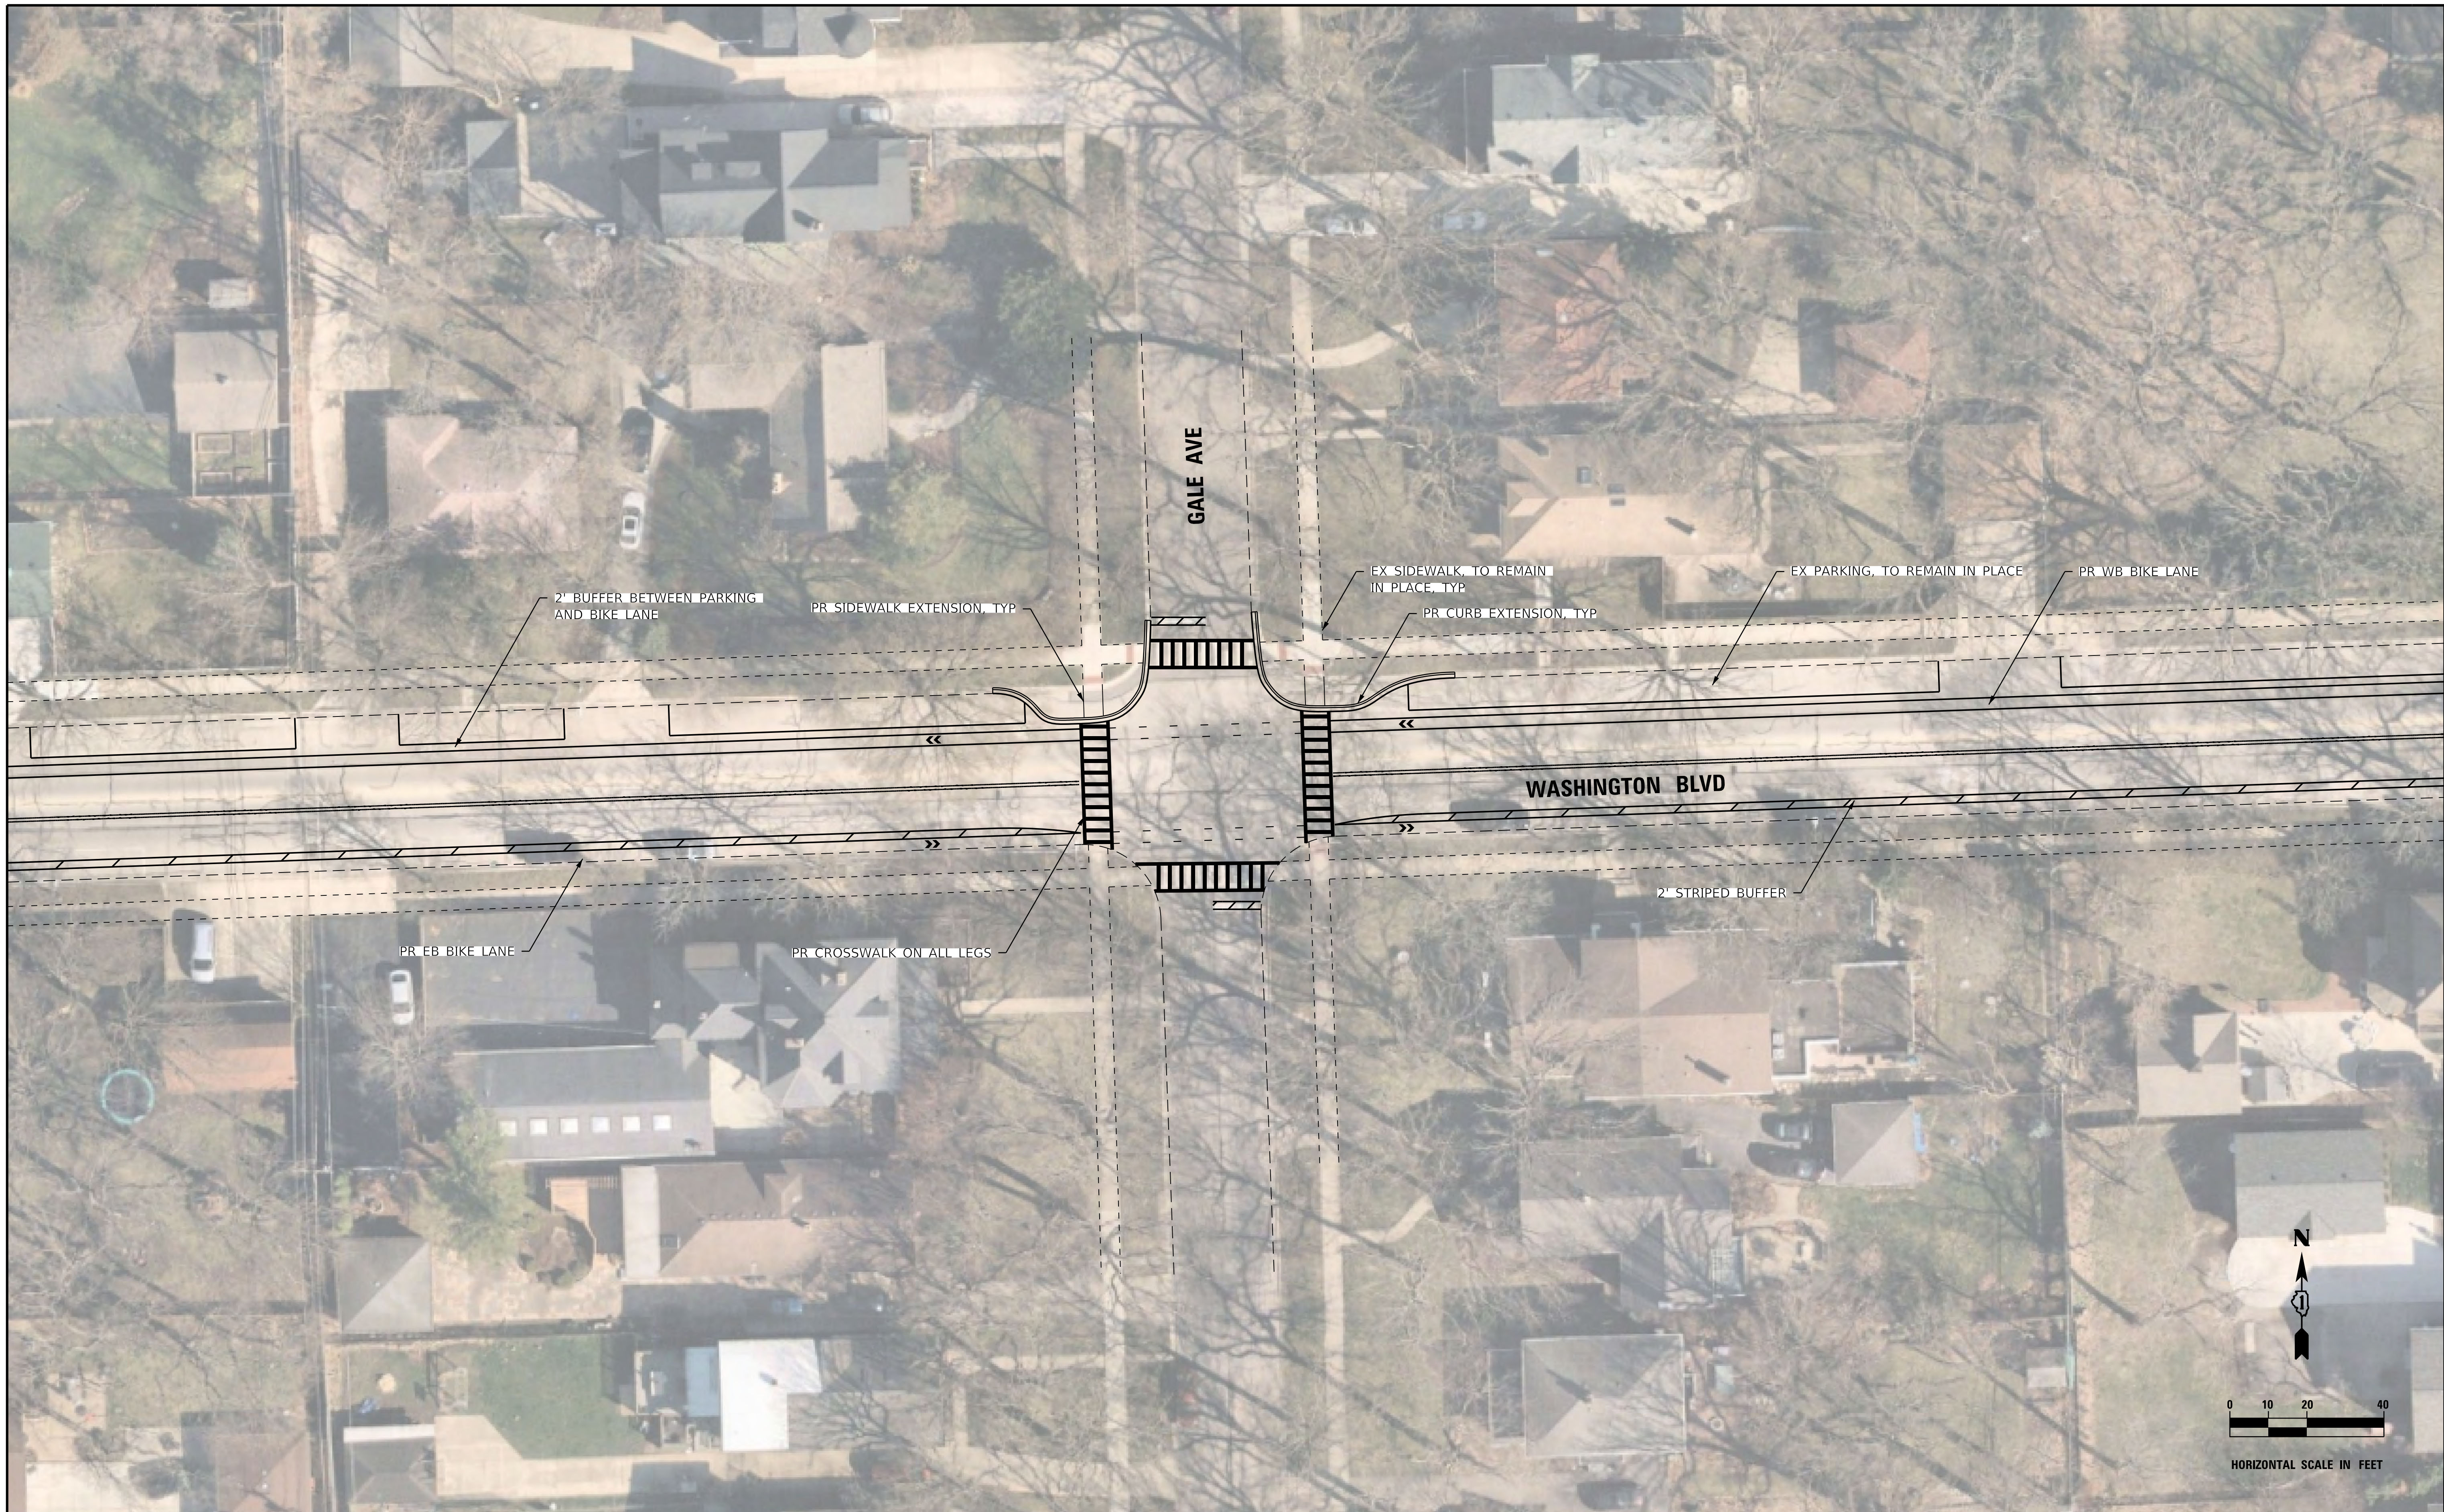
DRAWING NO.
5 OF 14

WASHINGTON AT GALE
ALTERNATIVE 1

Gale Ave suffers from the same elevated angle crash rate as Thatcher Ave including one pedalcyclist crash. Since Washington Blvd is not stopping at this intersection TEG theorizes that sight distance issues and speeding are the primary causes of the angle crashes. Residents verified this in survey response data. To increase visibility while decreasing visual clutter at the intersection parking on the south side of the road should be removed in favor of bike lanes. Curb extensions should be provided along the north side of Washington Blvd to bring pedestrians closer to oncoming traffic. Parking is available on Gale Ave and the north side of Washington Blvd for residents who can no longer park on the south side.

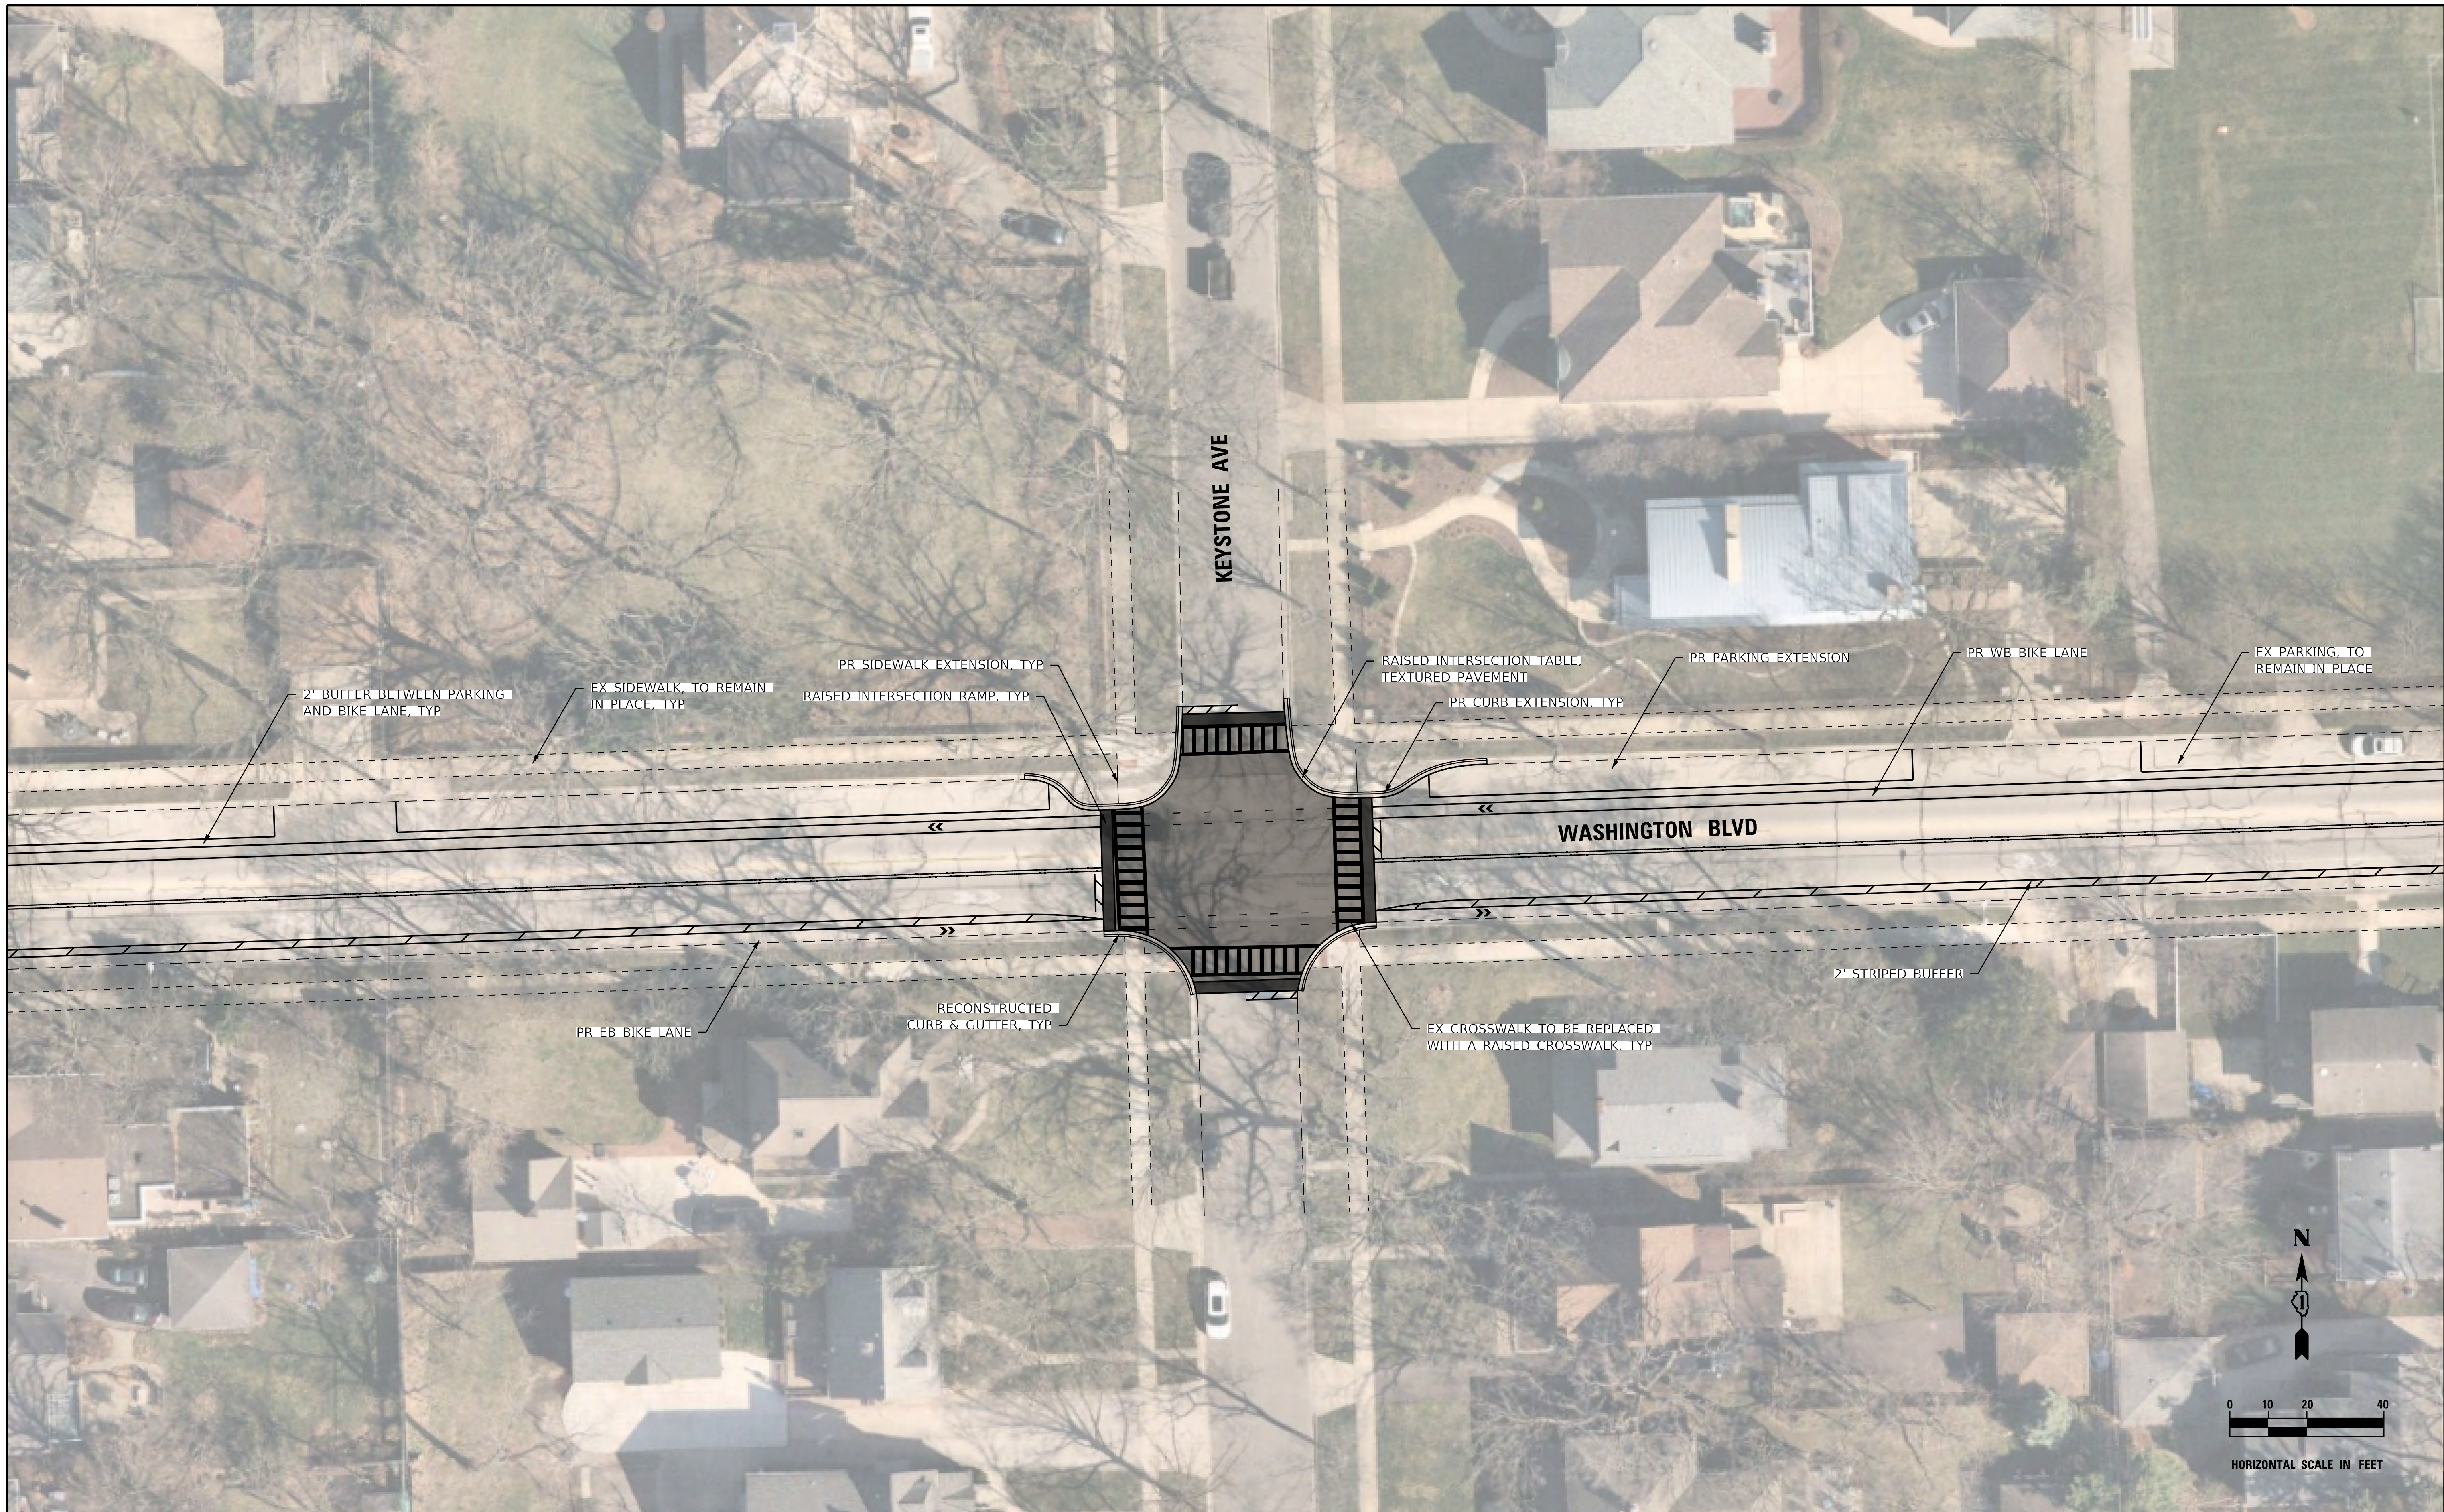
DRAWING NO.
 6 OF 14

**WASHINGTON AT KEYSTONE
 ALTERNATIVE 1**

Keystone Ave saw the same elevated angle crash rate as both Thatcher Ave and Gale Ave. Since this location is an all way stop similar improvements were recommended to those at Thatcher Ave. Sight distance seems to be worse for all legs of the intersection than Thatcher Ave due to large trees and landscaping near the intersection. TEG recommend installing a raised intersection to provide multiple points of traffic calming as a driver moves along Washington Blvd.

TEG recommends removing street parking along the south side of the road to provide bike lanes. Curb extensions should be provided along the north side of Washington Blvd to bring pedestrians closer to oncoming traffic. Signs to not drive in the parking lane are a result of unused parking in the area and evidence that drivers attempt to improperly use the parking lane as a second lane. At the all way stop intersection this can be dangerous if drivers on the other legs are not expecting a second lane of traffic.

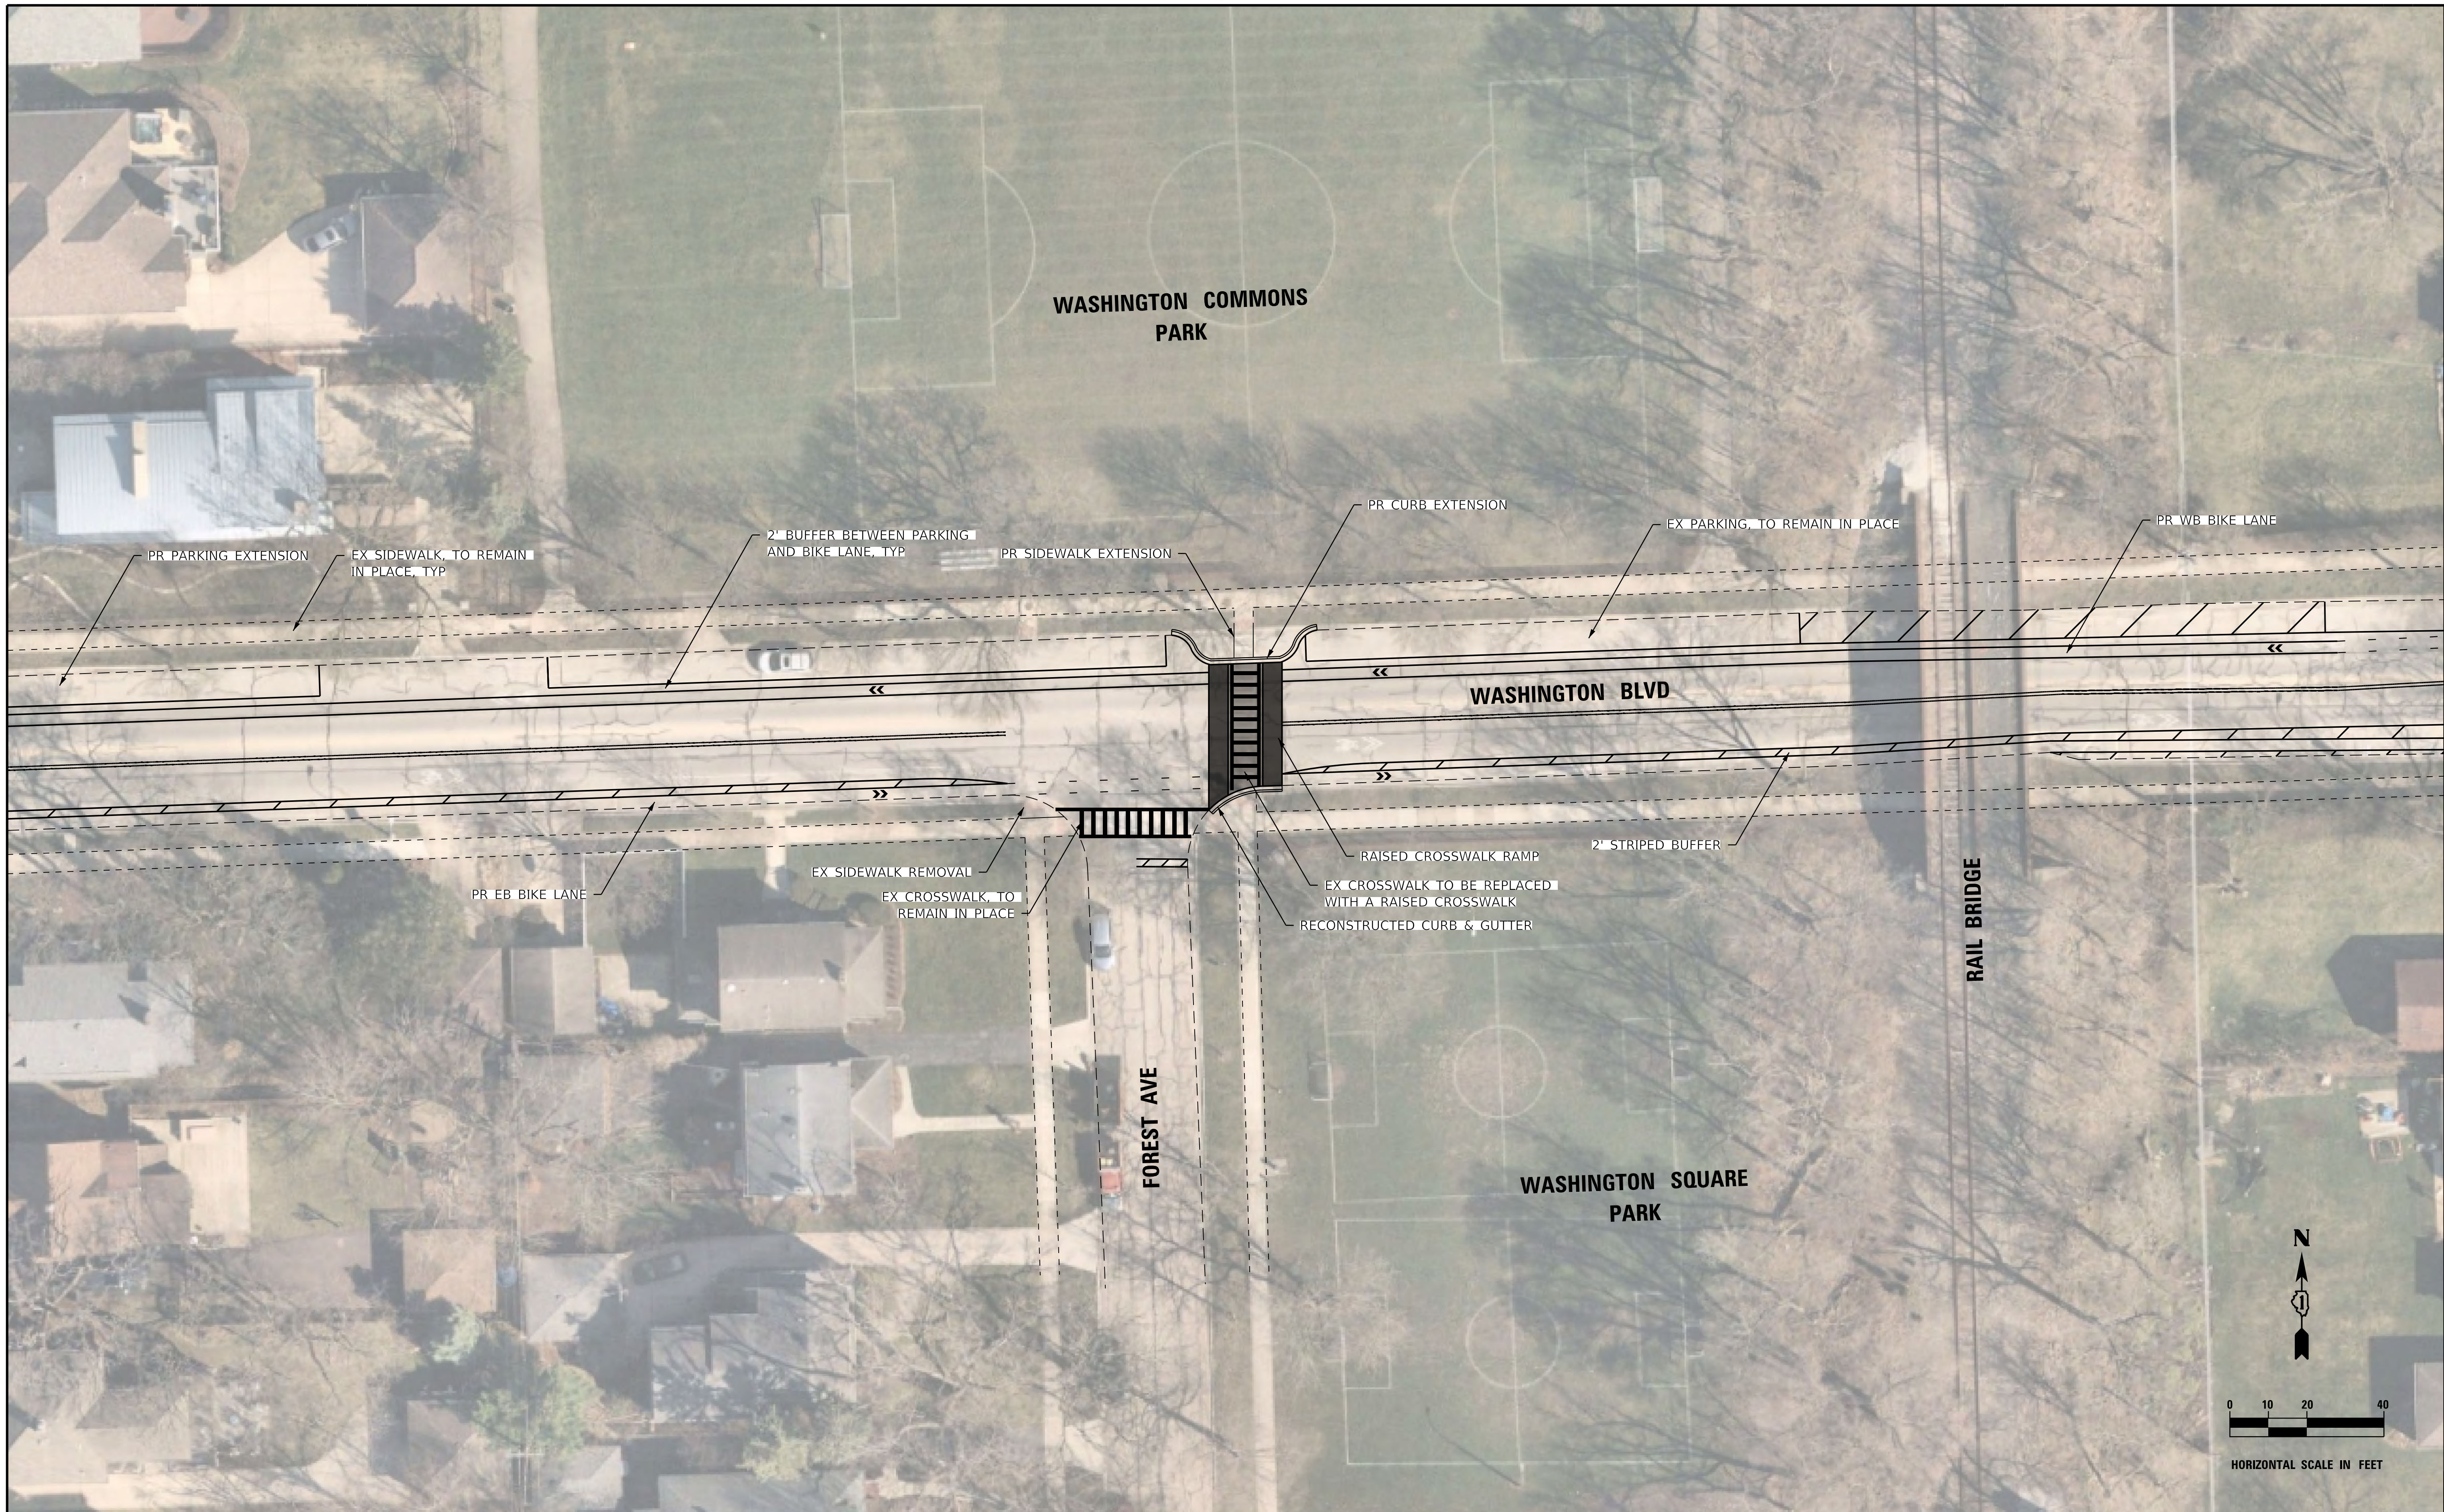
DRAWING NO.
 7 OF 14

**WASHINGTON AT FOREST
 ALTERNATIVE 1**

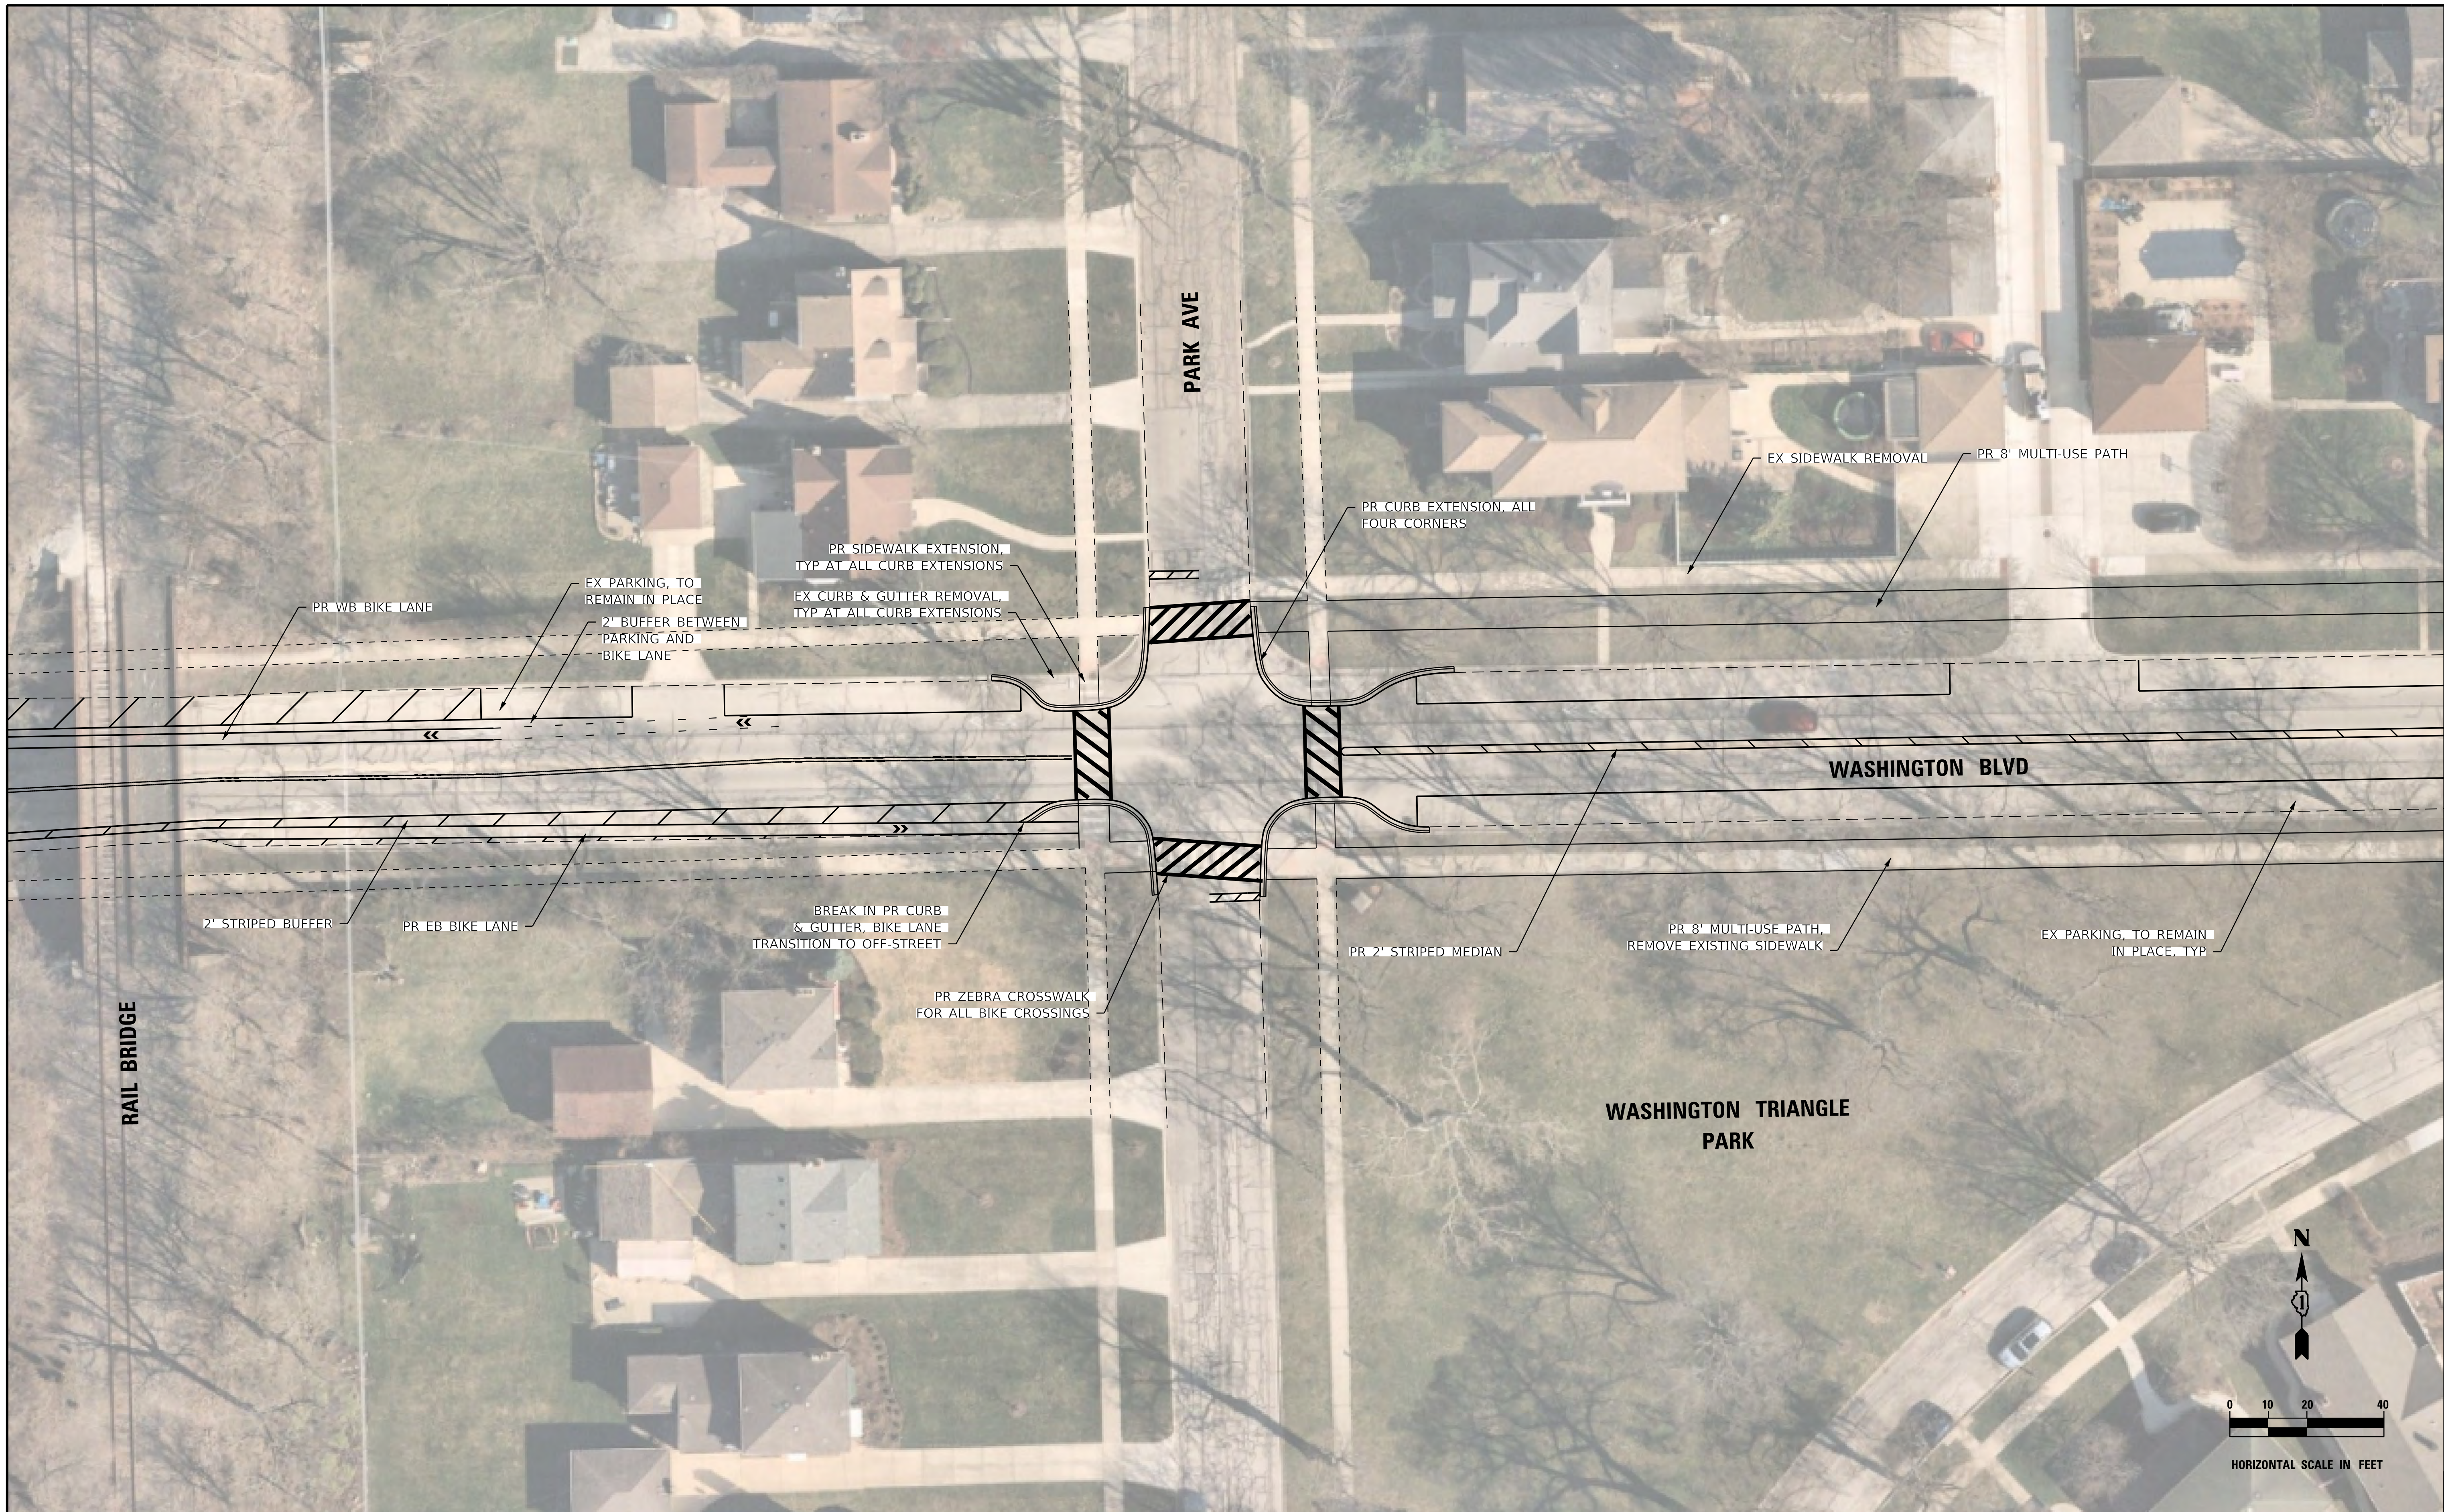
DRAWING NO.
 8 OF 14

**WASHINGTON AT PARK
 ALTERNATIVE 1**

Park Ave has a low crash rate similar to Forest Ave and in this case, TEG recommends transitioning away from the cross section starting at Thatcher Ave to a new cross section that matches the existing conditions with the addition of narrower 11' lanes and a 2' striped median. All four legs should have their crosswalk striping updated to zebra striping. Signing in the area includes a "Stop here for pedestrians" sign for the crosswalk on Franklin Ave. It is unclear that the sign is referring to the crosswalk on Franklin Ave based on how far it is placed from that intersection. TEG suggests relocating the sign consistent with other areas of the Village.
