WASHINGTON BLVD CORRIDOR STUDY

Introduction

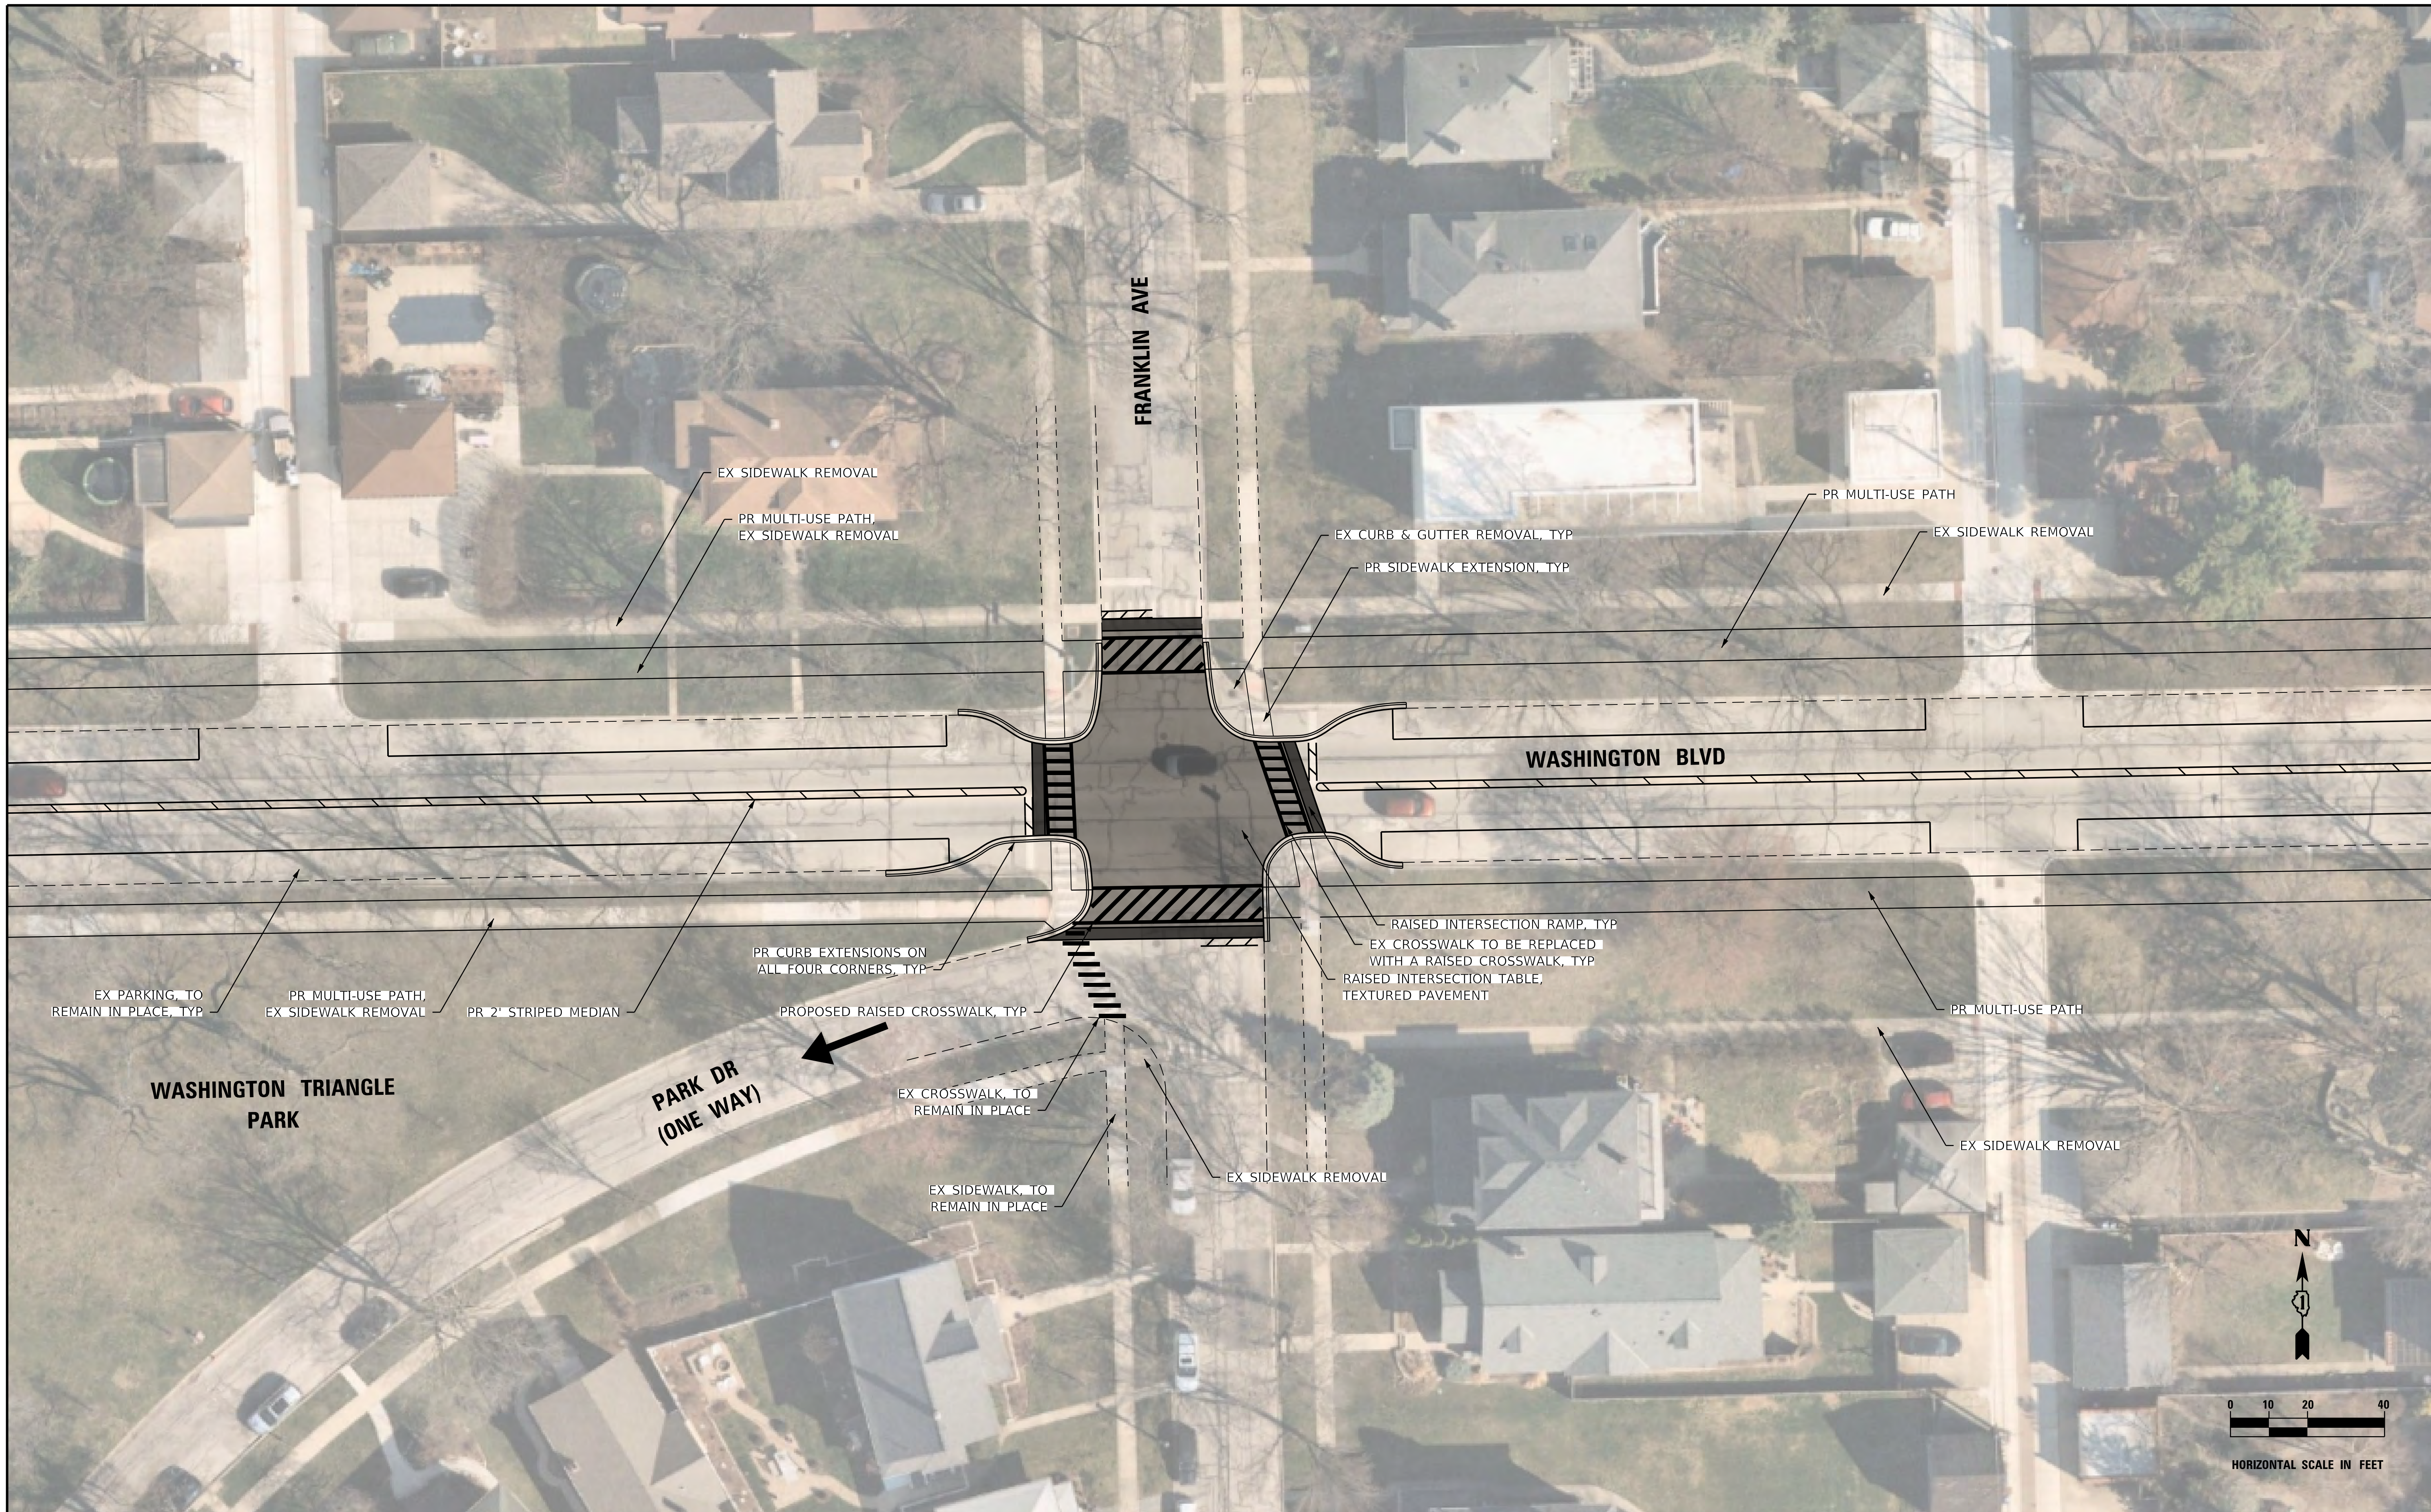
DRAWING NO.
9 OF 14

**WASHINGTON AT FRANKLIN
ALTERNATIVE 1**

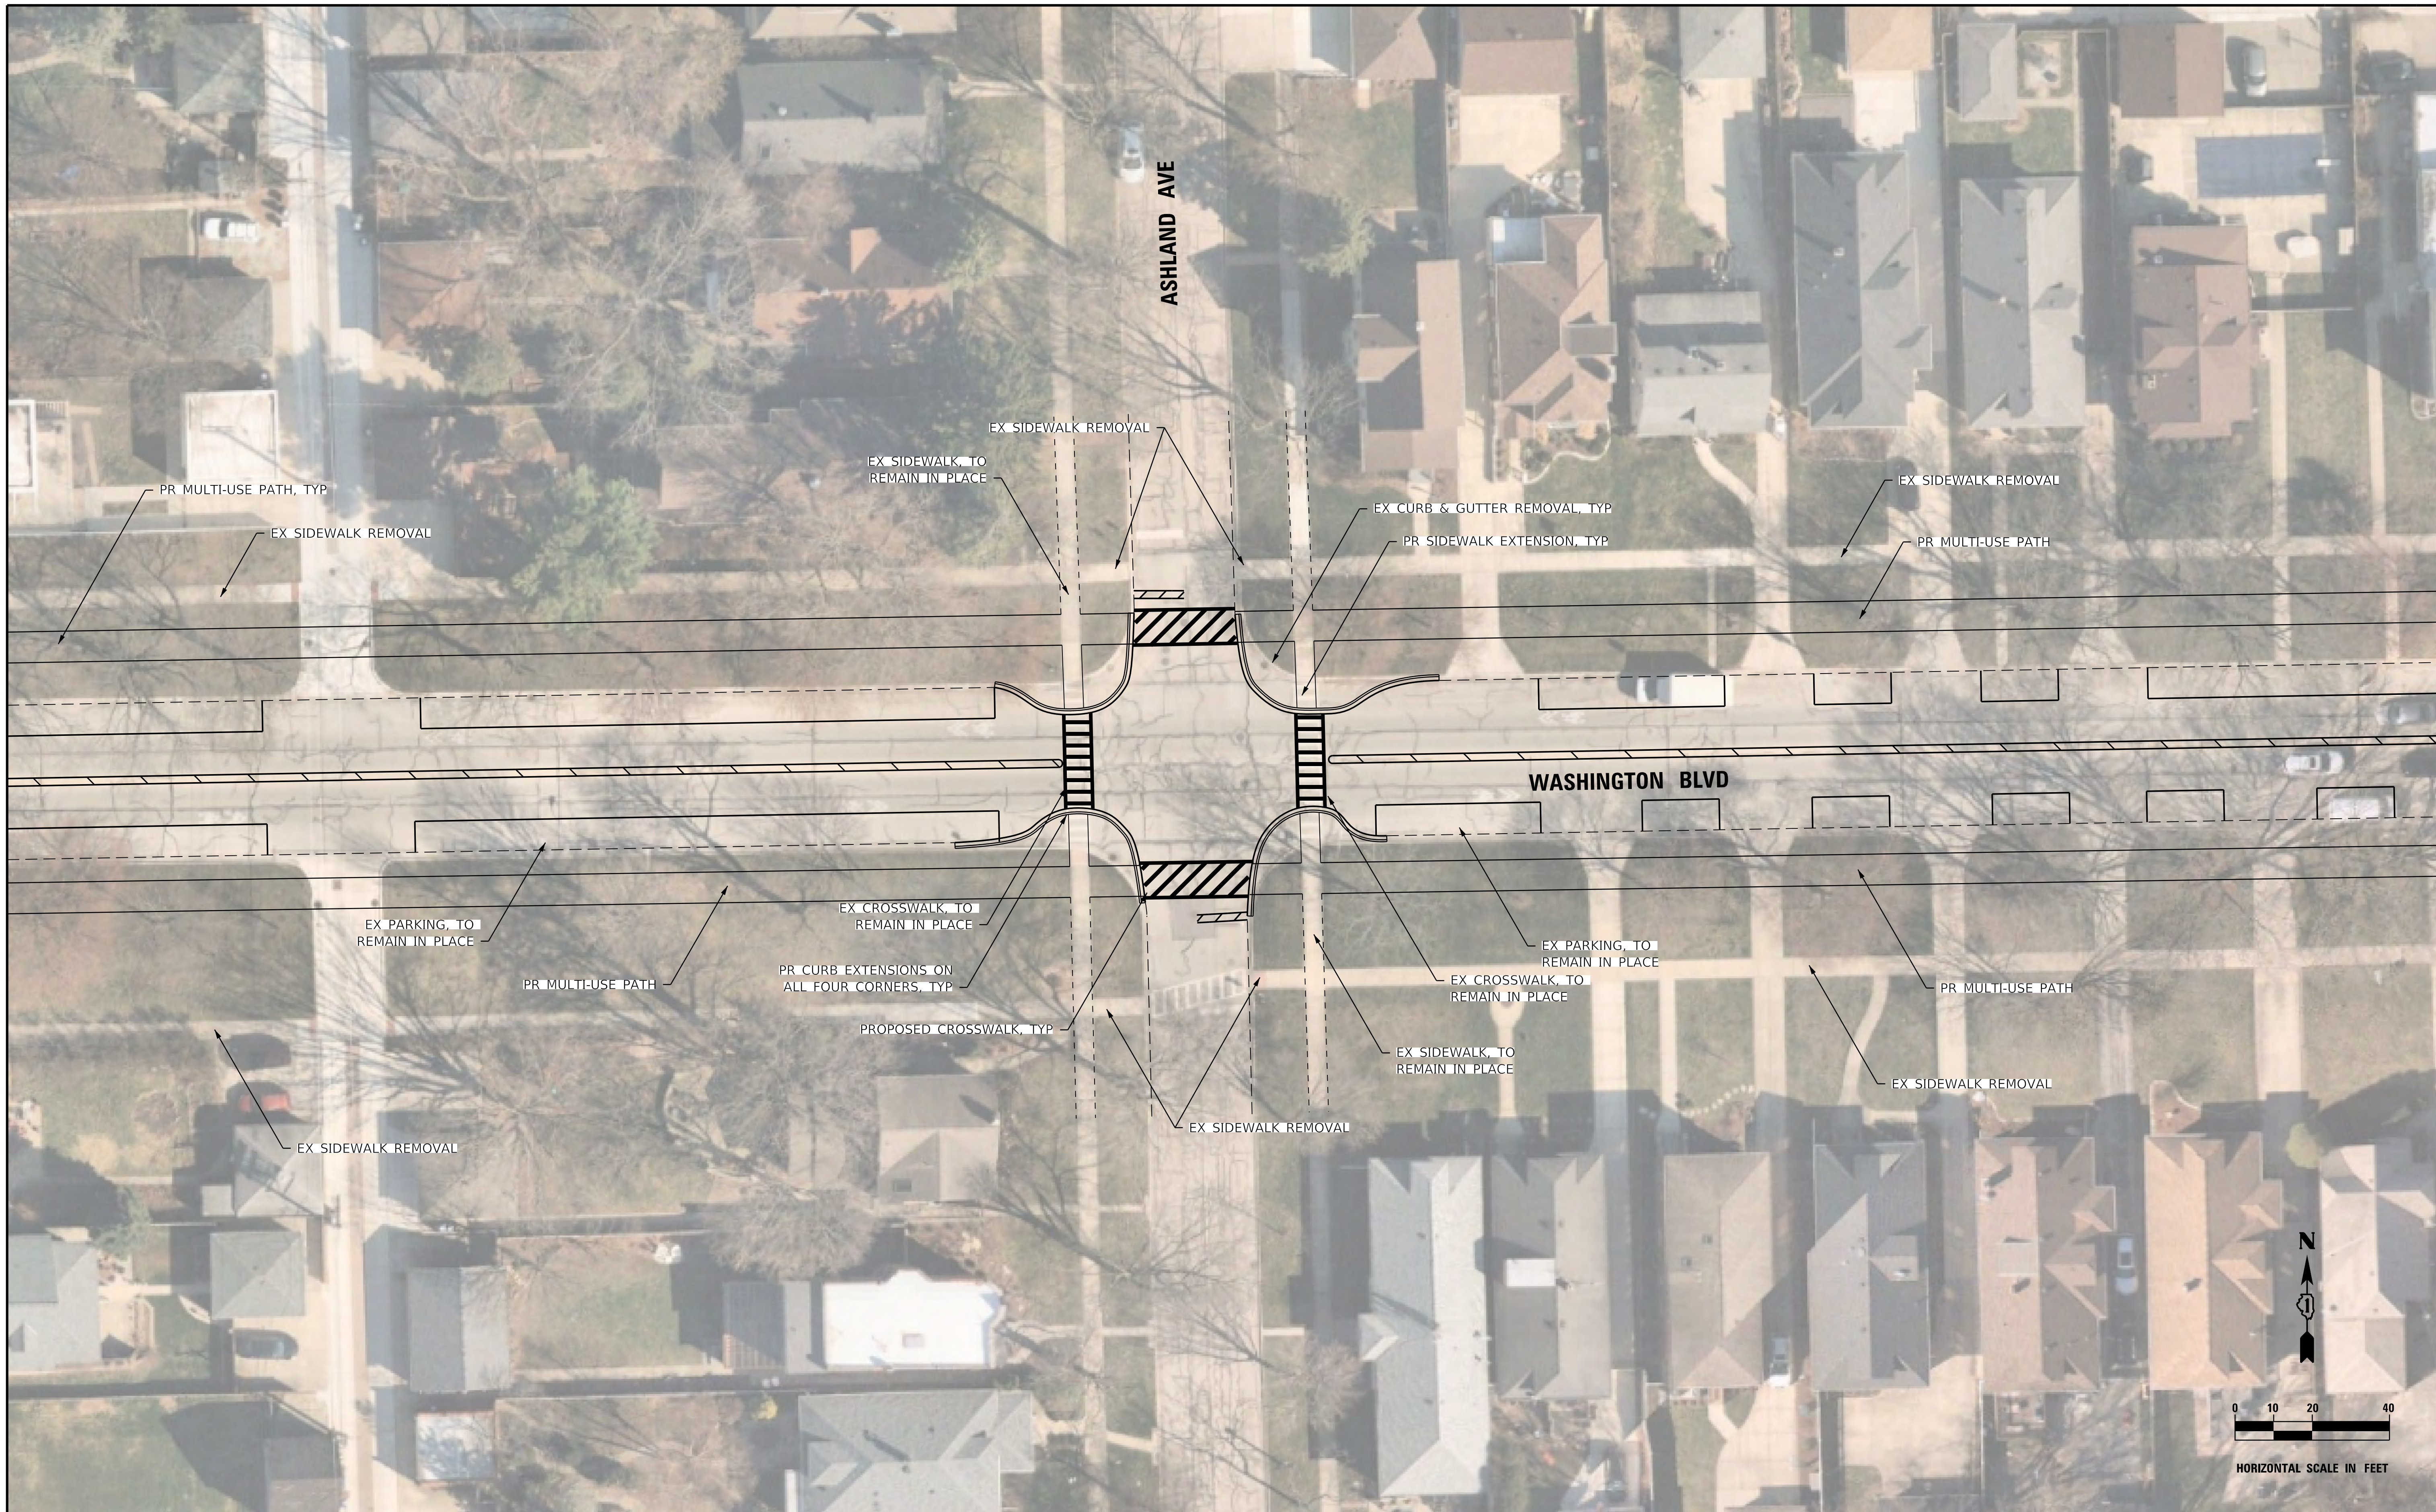
DRAWING NO.
 10 OF 14

**WASHINGTON AT ASHLAND
 ALTERNATIVE 1**

The moderate spike in residents saying drivers were rolling the stop signs on Ashland Ave (14) may be an effect of the setback geometry of the minor legs. Drivers approaching Washington Blvd from Ashland may go past the stop bar while stopping to get a better view of oncoming traffic. Currently drivers are stopped over 40' away from Washington Blvd which is more than double the setback of intersections in the western half of the corridor. Geometric modifications would improve functionality and driver behavior without requiring further traffic calming.
